# AXOD/AXODE (AX4S) UPDATE HANDBOOK

*Updated  
October, 2002*

Since the introduction of the Ford AXOD transaxle in model year 1986, there have been many major engineering design changes that have affected many of the parts used in the AXOD transaxle. This version of the AXOD "Update Handbook" begins with the 1986 model year and will explain each change, the parts affected by the change, and any parts interchange problems created by the change. This booklet is an updated version of the original.

This updated version of the AXOD "Update Handbook" will also cover the changes that occurred in the 1991 model year, when electronic controls were adapted to the AXOD transaxle, making it an AXODE, and now called an AX4S transaxle. We have included the changes on the AX4S transaxle up through and including model year 2002.

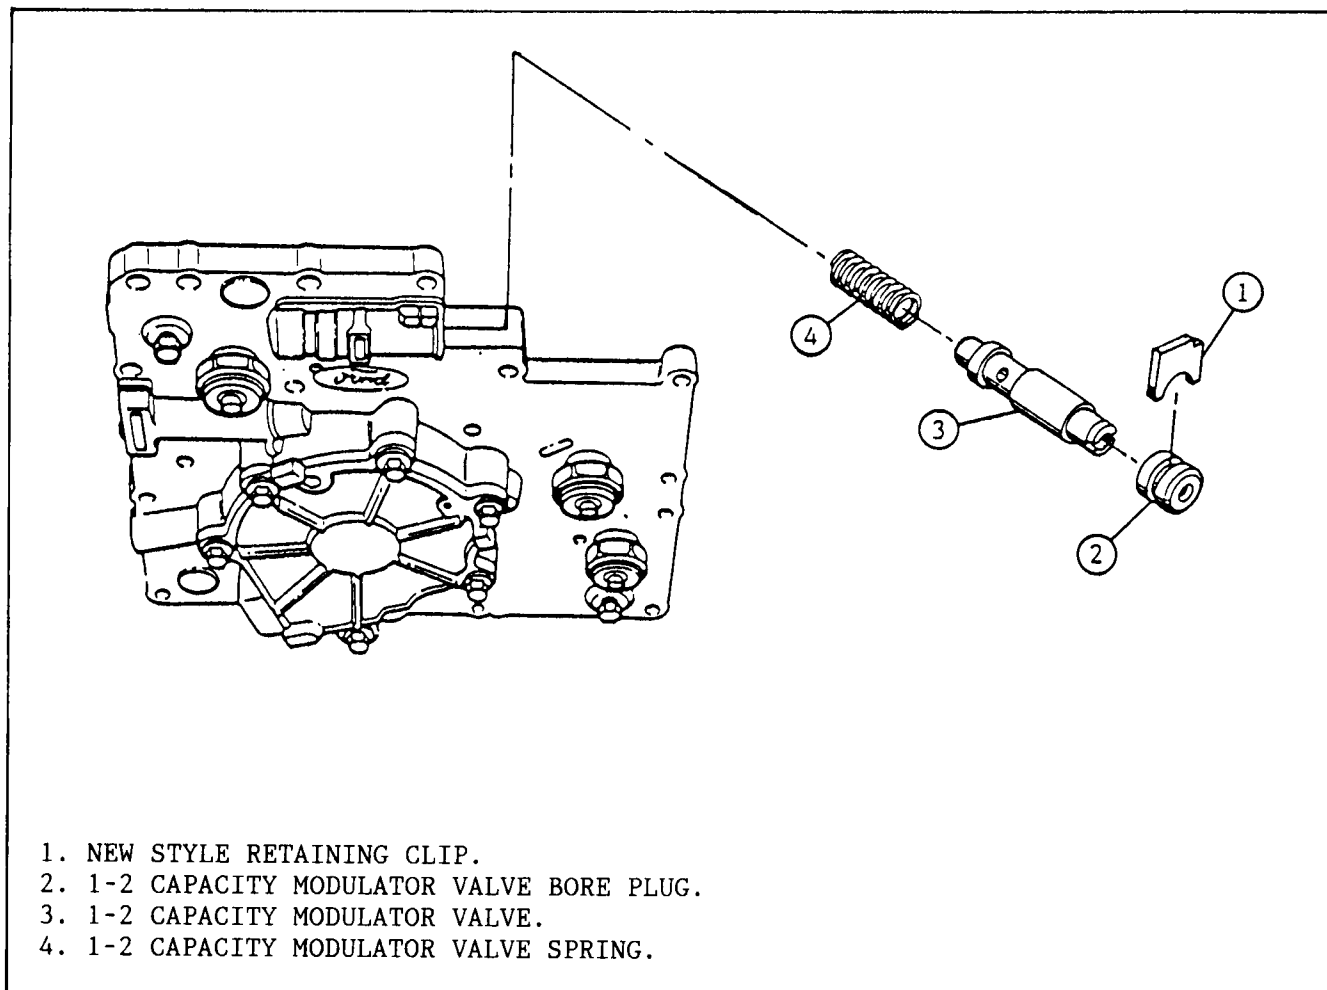
Figure 18

CAUSE: The cause may be a lack of oil volume to the intermediate and/or direct clutch packs.

CORRECTION: FOR SOFT 1-2 SHIFT:  
Replace the 1-2 capacity modulator valve spring with the Red spring manufactured by Shift Technology Products (Part #K006). The kit also comes with a new style bore plug retaining clip. Assemble into the oil pump as shown in Figure 18. This modification should be made on all AXOD'S during rebuild.

NOTE: Do not install the valve backwards, as the result will be a one-neutral shift.

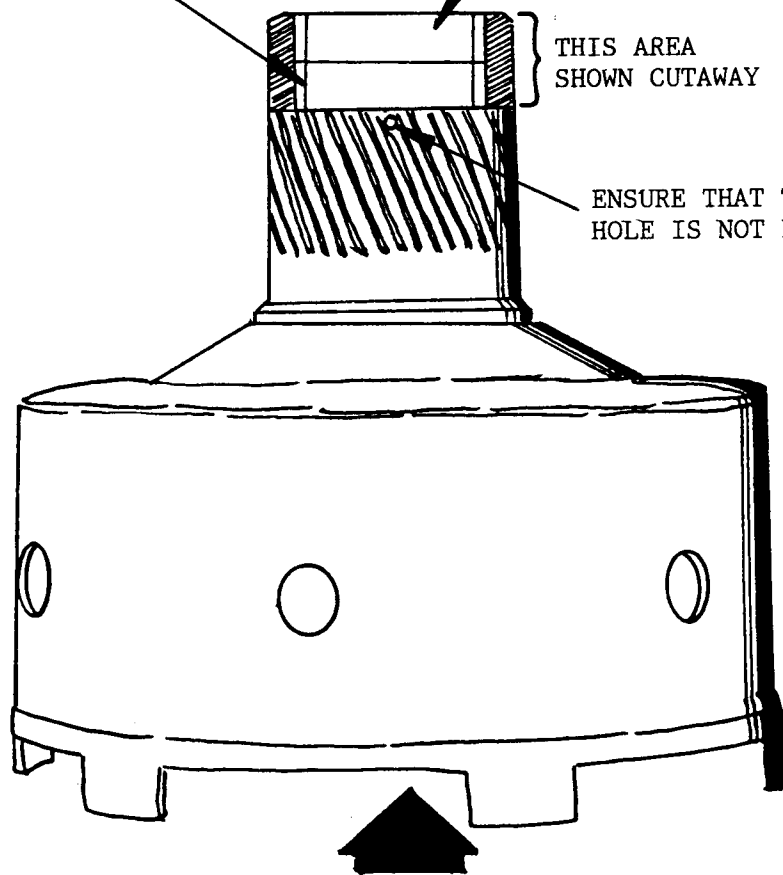
Figure 31

ENSURE THAT THIS LUBE HOLE IS NOT BLOCKED.

5. Install "Double Bushings" at the rear of sun gear as shown in Figure 31. After both bushings are in place, ensure that lube oil hole in the sun gear is not blocked.

SUPPORT SUN GEAR FROM THIS END WHILE PRESSING BUSHINGS TO PREVENT DAMAGE TO SUN GEAR SHELL.

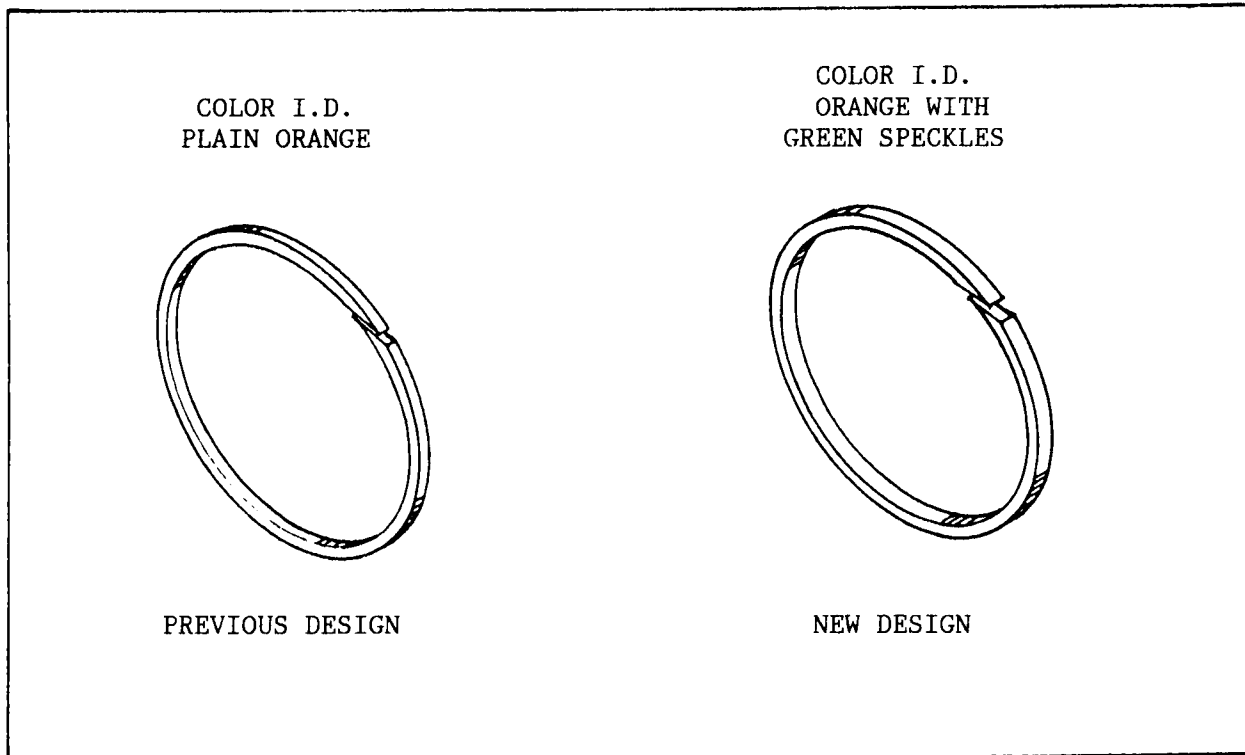
Figure 37

The five sealing rings on the driven sprocket support have been re-designed to help eliminate leakage in this area. The width of the sealing rings has been increased by approximately .015", and the new color identification is orange with green speckles (See Figure 37). The previous design sealing rings were plain orange in color.

The new design sealing rings are available under OEM number E6DZ-7D019-A, and should be used on ALL previous model AXOD transaxles.

DO NOT USE PREVIOUS DESIGN SEALING RINGS.

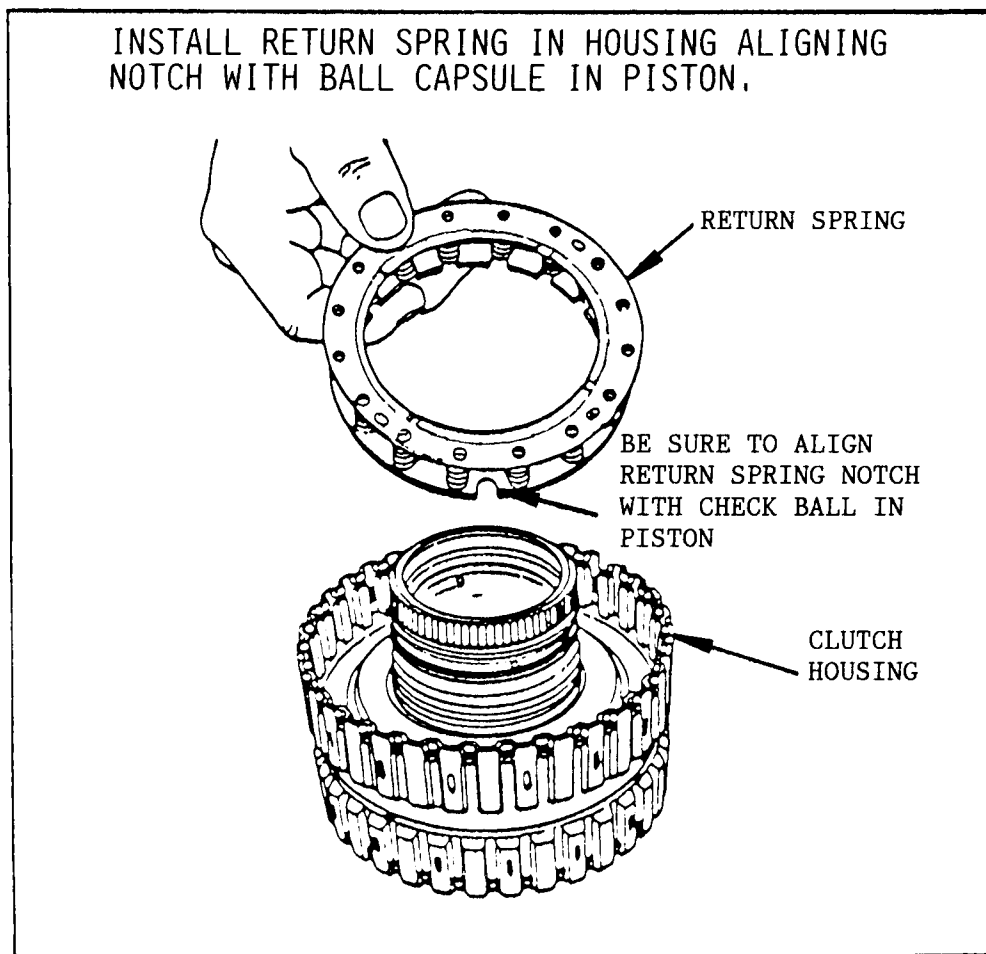
Figure 41

**COMPLAINT:** An extended 3-4 shift with possible direct clutch failure or a NO 3-4 shift condition.

**CAUSE:** This condition may be caused by a partially or fully blocked oil flow of the direct clutch piston check ball assembly.

**CORRECTION:** Special care must be taken during the overhaul operation when re-assembling the direct clutch return spring over the direct clutch piston. Make sure that the notch in the spring bottom retainer (See Figure 41) is positioned properly over the check ball capsule so as not to block or restrict oil flow of the check ball assembly. Refer to Figure 41.

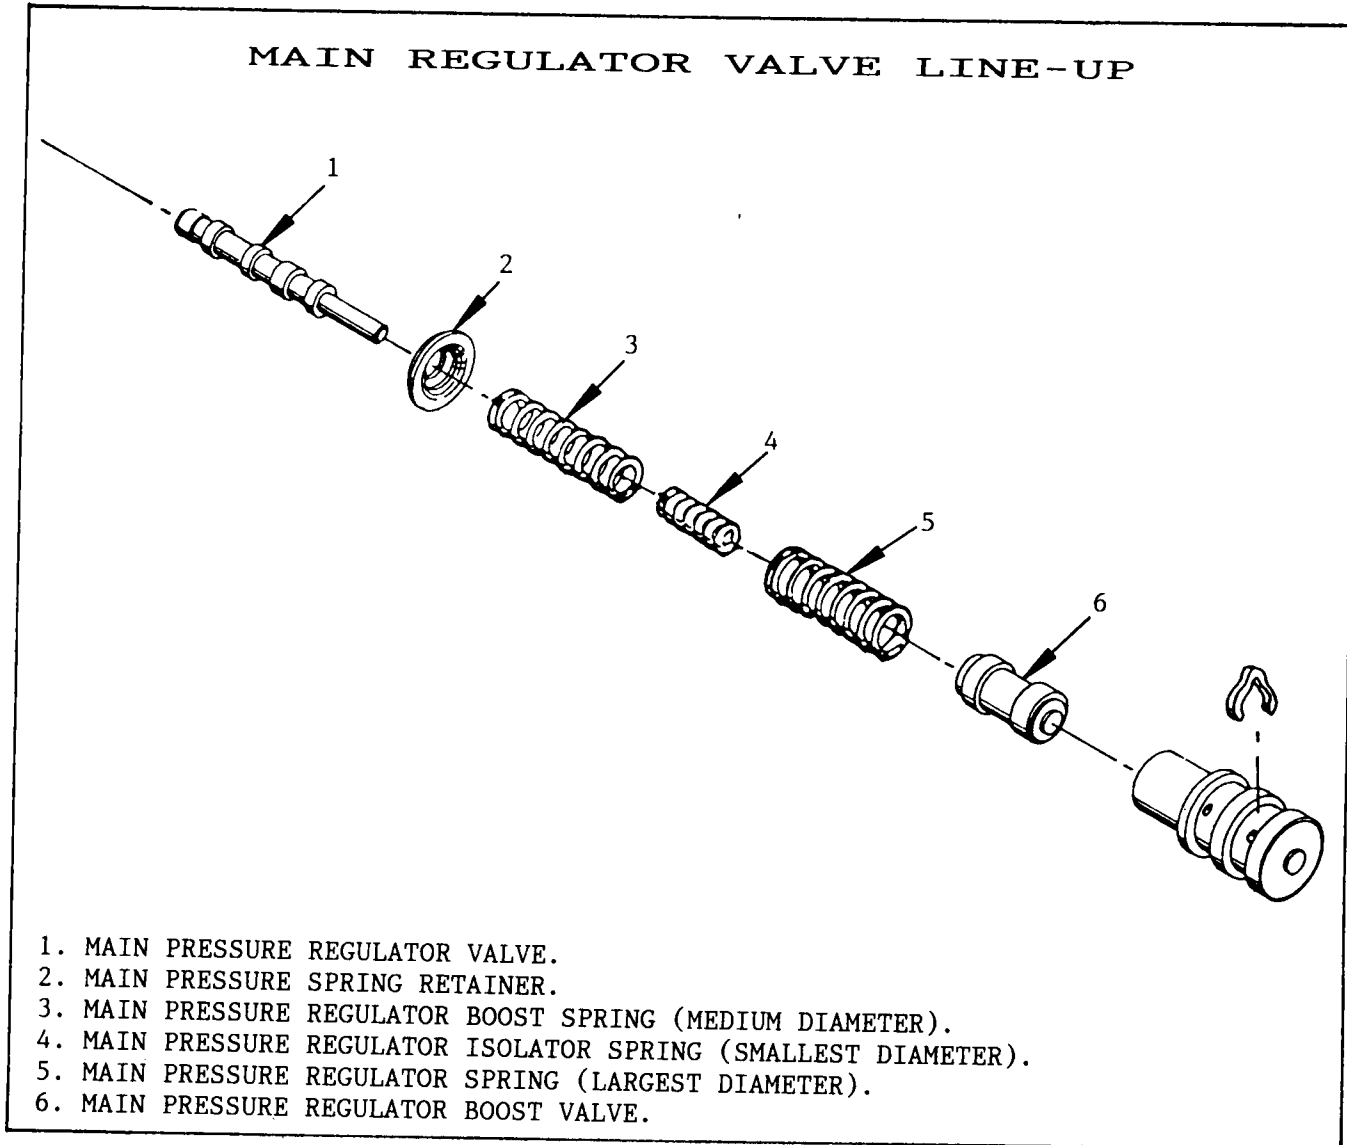
Figure 43

- CAUSE:
- NO. 1. A "Shudder" during a 1-2 upshift will occur if the main pressure regulator "Isolator" spring is not installed after cleaning the valve body (See Figure 43). This is caused by fluctuations in main line pressure at the time of the 1-2 shift.
  - NO. 2. Delayed upshifts can be caused by the pressure regulator spring retainer being installed backwards (See Figure 43). This will create low main line pressure.

- CORRECTION:
- NO. 1. Insure that all three (3) pressure regulator springs are re-installed in the valve body regulator bore (See Figure 43).
    - 1. Main Pressure Regulator Spring (Largest Diameter).
    - 2. Main Regulator Boost Spring (Medium Diameter).
    - 3. Main Regulator Isolator Spring (Smallest Diameter).
  - NO. 2. Insure that the main regulator spring retainer is installed in the proper direction (See Figure 43). The retainer is very similar to the one used in the AOD valve body, but is installed in the opposite direction of the AOD (See Figure 43).

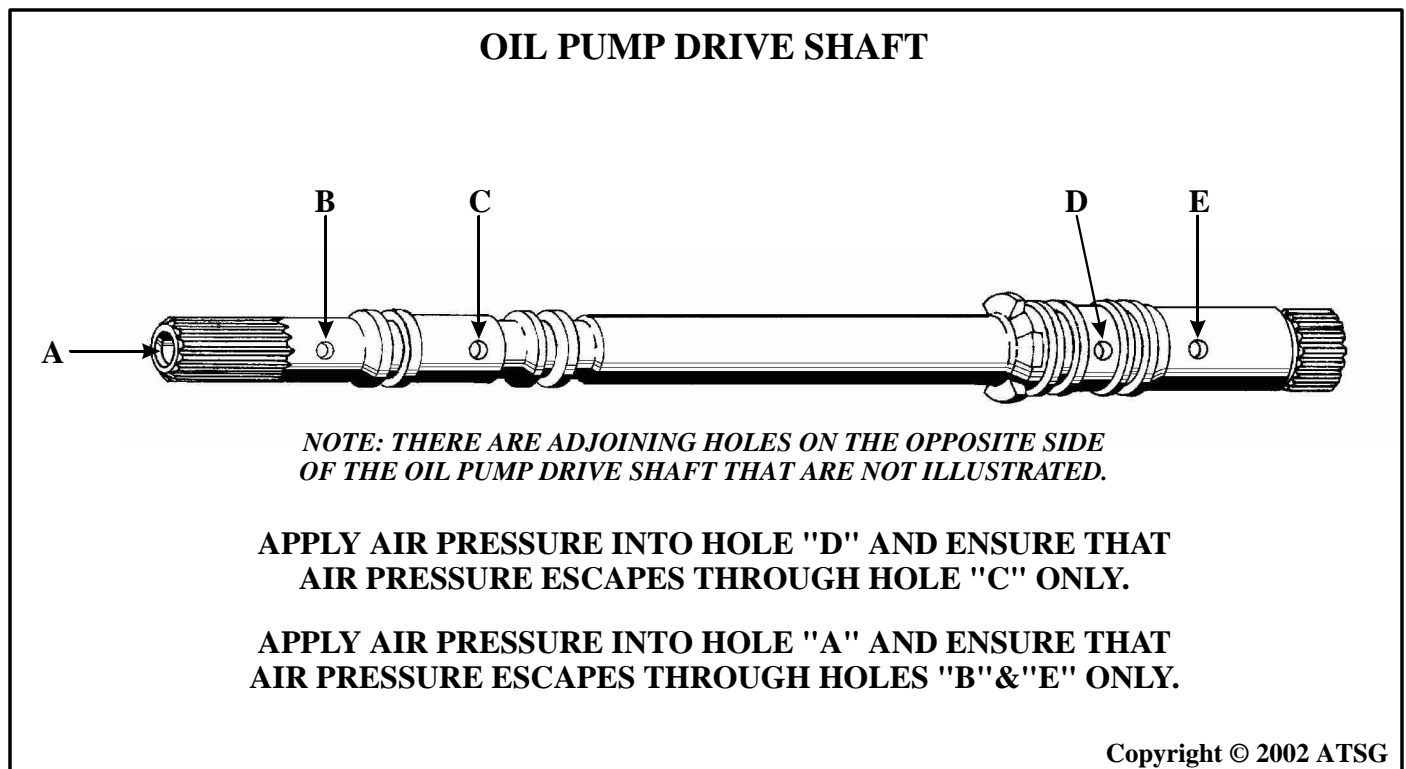
1. *The converter feed passage in the Oil Pump Drive Shaft blocked with debris or was not machined properly to allow converter feed oil to enter the converter.*
2. *The Oil Pump Drive Shaft leaking or not machined properly, allowing converter feed passage and converter release passage to be connected.*

**NOTE:** *We have seen some replacement shafts, both reman and new that were leaking between the converter apply and release passages.*

**CORRECTION:** Refer to Figure 64 to *check* the Oil Pump Drive Shaft, and clean or replace as necessary.

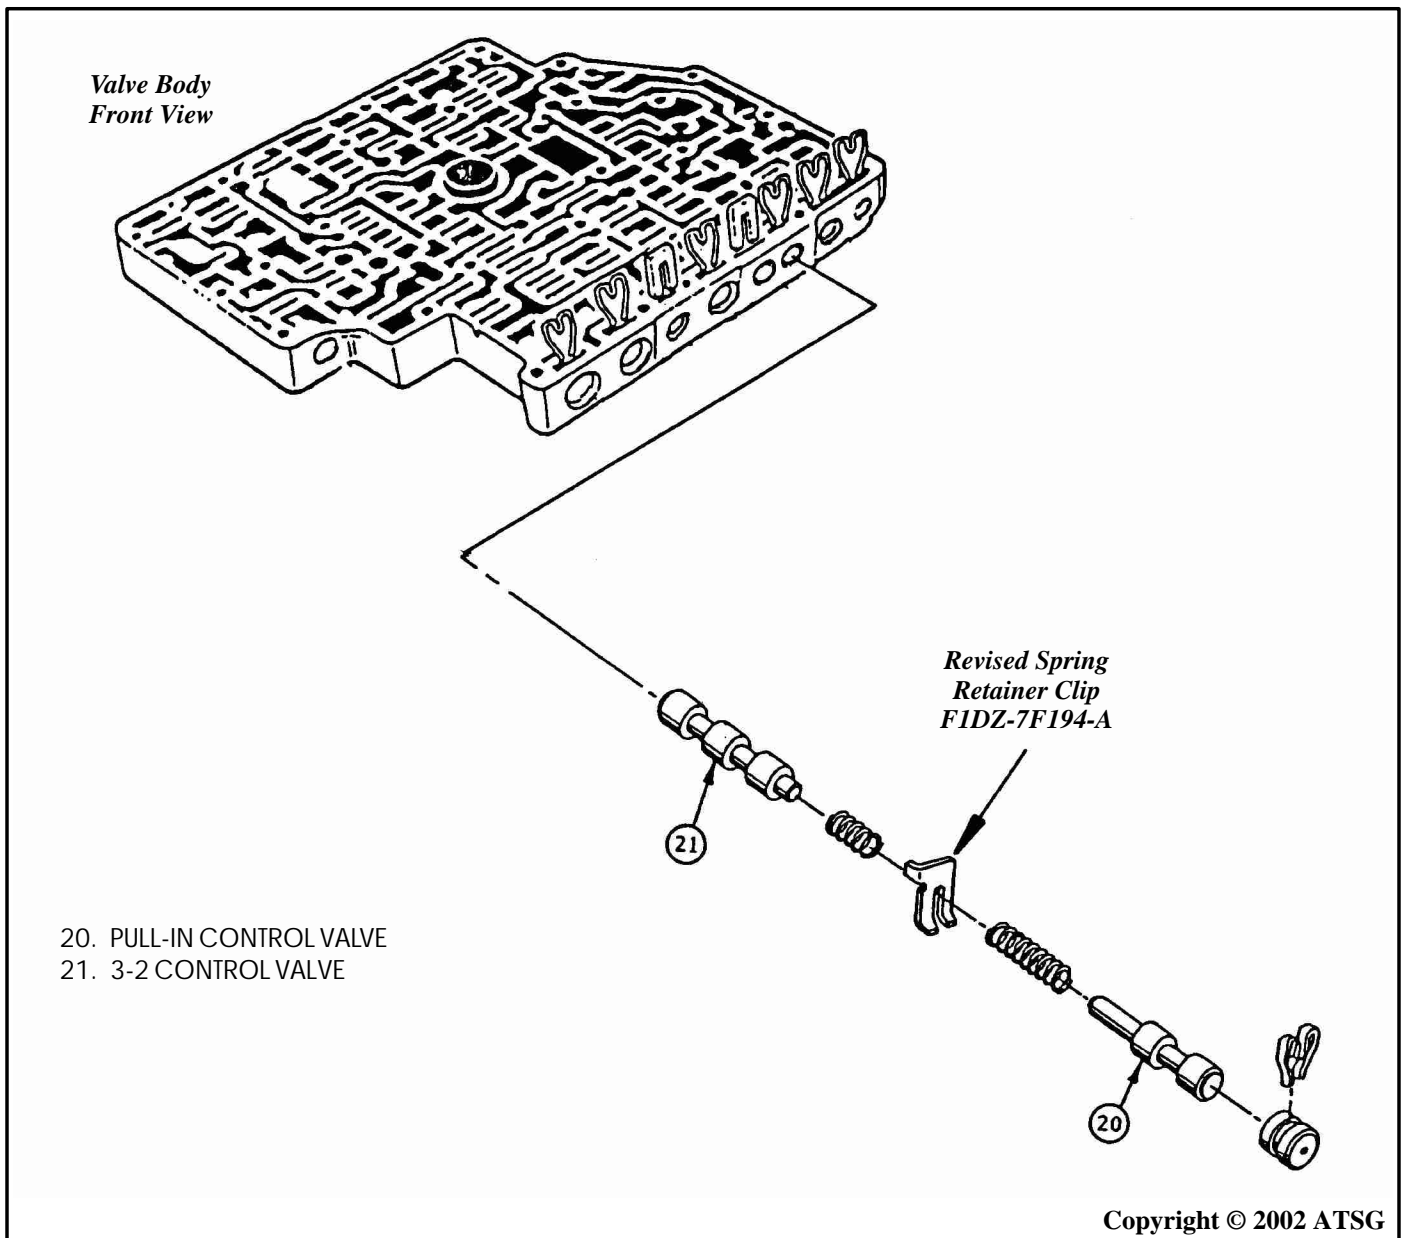
Figure 75

**CAUSE:** The cause may be, a broken spring retainer clip between the pull-in control valve spring and the 3-2 control valve spring, as shown in Figure 75.

**CORRECTION:** Replace the spring retainer clip with OEM part number F1DZ-7F194-A, as shown in Figure 75.

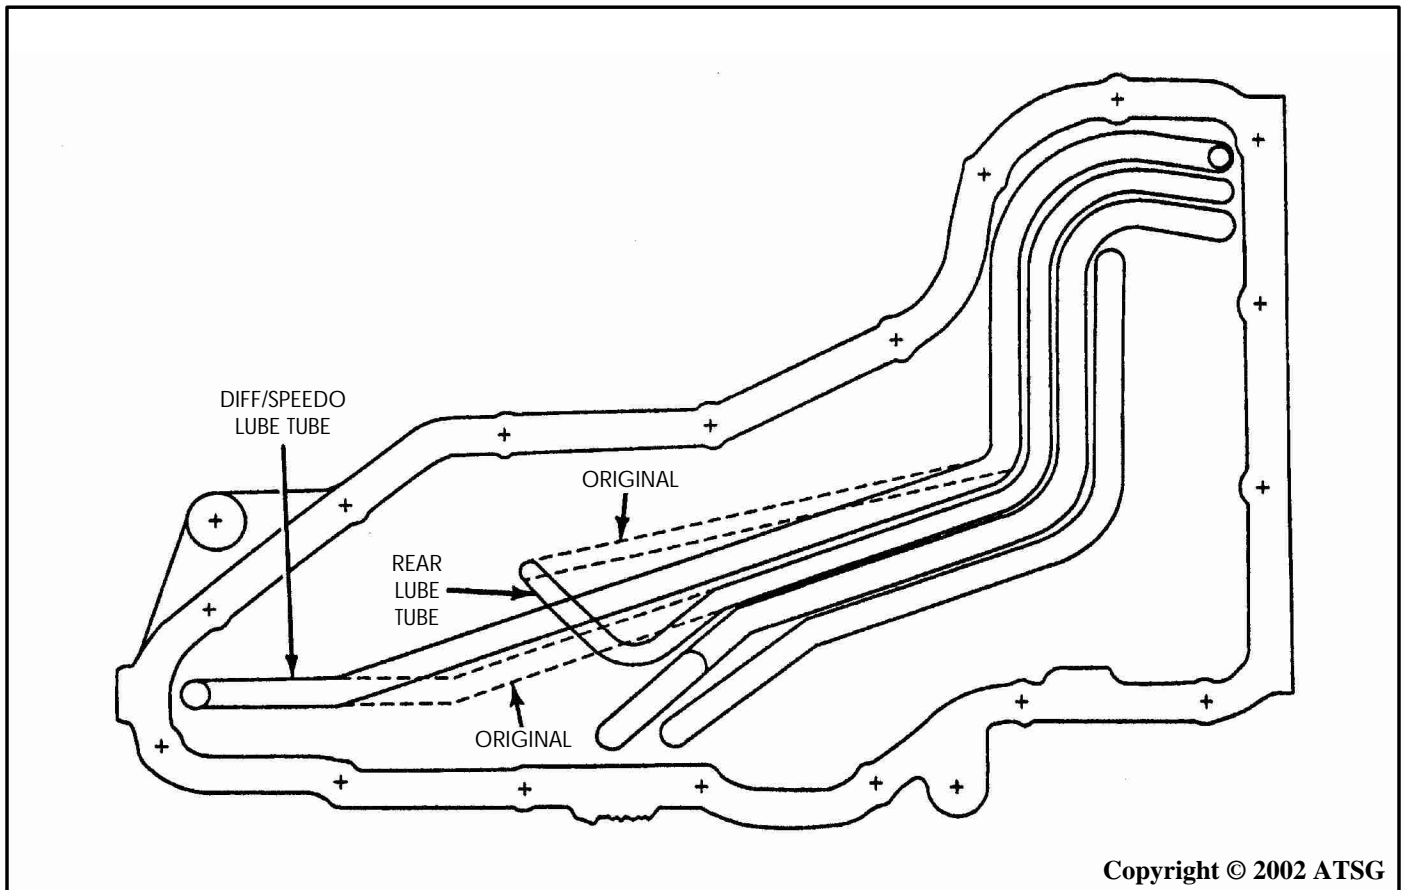
Figure 83

**COMPLAINT:** Front planetary and gear train failure with no visible root cause.

**CAUSE:** The cause may be, a limited volume of lube oil to the front planetary due to hydraulic control system demands.

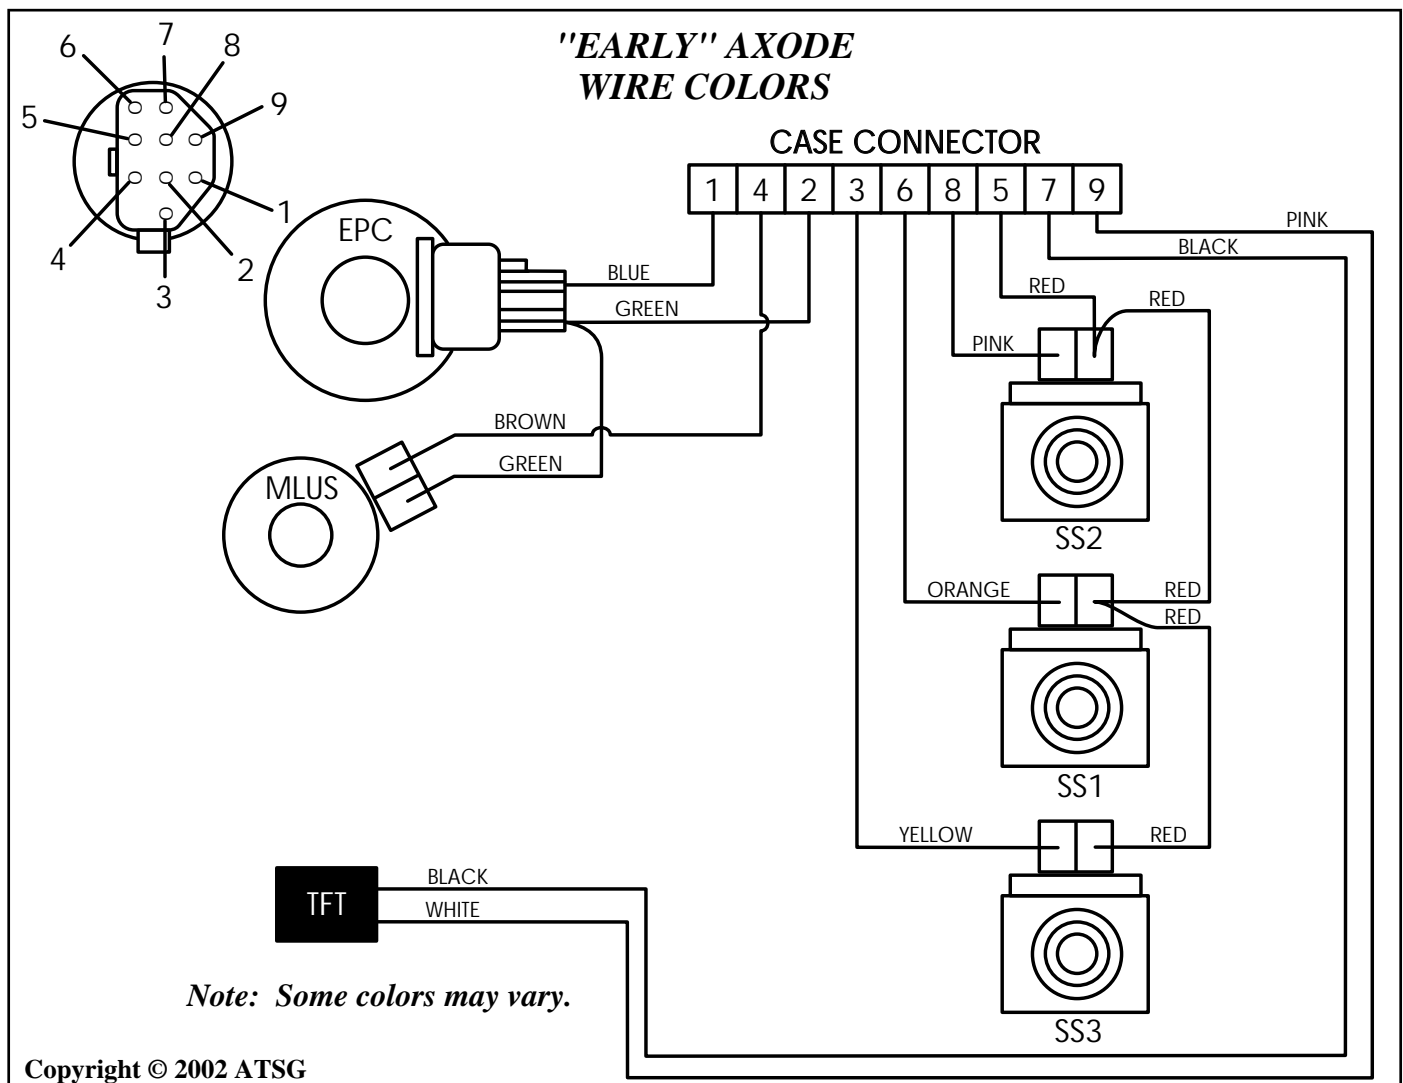
Figure 90

**COMPLAINT:** *After rebuild*, harsh shifts (High Line) and/or a "Clicking" or cycling noise may be heard from the side cover area, that is usually accompanied by an ON/OFF bind-up sensation that coincides with the "Clicking" noise. These symptoms may be accompanied with Diagnostic Trouble Code (DTC) 652 (MLUS Shorted or Open Circuit), DTC 624 (EPC Circuit Failure), and/or one Shift Solenoid DTC 621, 622, or 624.

**CAUSE:** The cause may be, solenoid wire connectors installed on the wrong solenoids.

**NOTE:** The internal wire harness normally is secured by wire-ties which would prevent improper connection of solenoids, however, not all wire harnesses have the wire ties necessary to prevent this problem and the chart must be used.
