# AXOD/AXODE (AX4S) UPDATE HANDBOOK

*Updated  
October, 2002*

Since the introduction of the Ford AXOD transaxle in model year 1986, there have been many major engineering design changes that have affected many of the parts used in the AXOD transaxle. This version of the AXOD "Update Handbook" begins with the 1986 model year and will explain each change, the parts affected by the change, and any parts interchange problems created by the change. This booklet is an updated version of the original.

This updated version of the AXOD "Update Handbook" will also cover the changes that occurred in the 1991 model year, when electronic controls were adapted to the AXOD transaxle, making it an AXODE, and now called an AX4S transaxle. We have included the changes on the AX4S transaxle up through and including model year 2002.

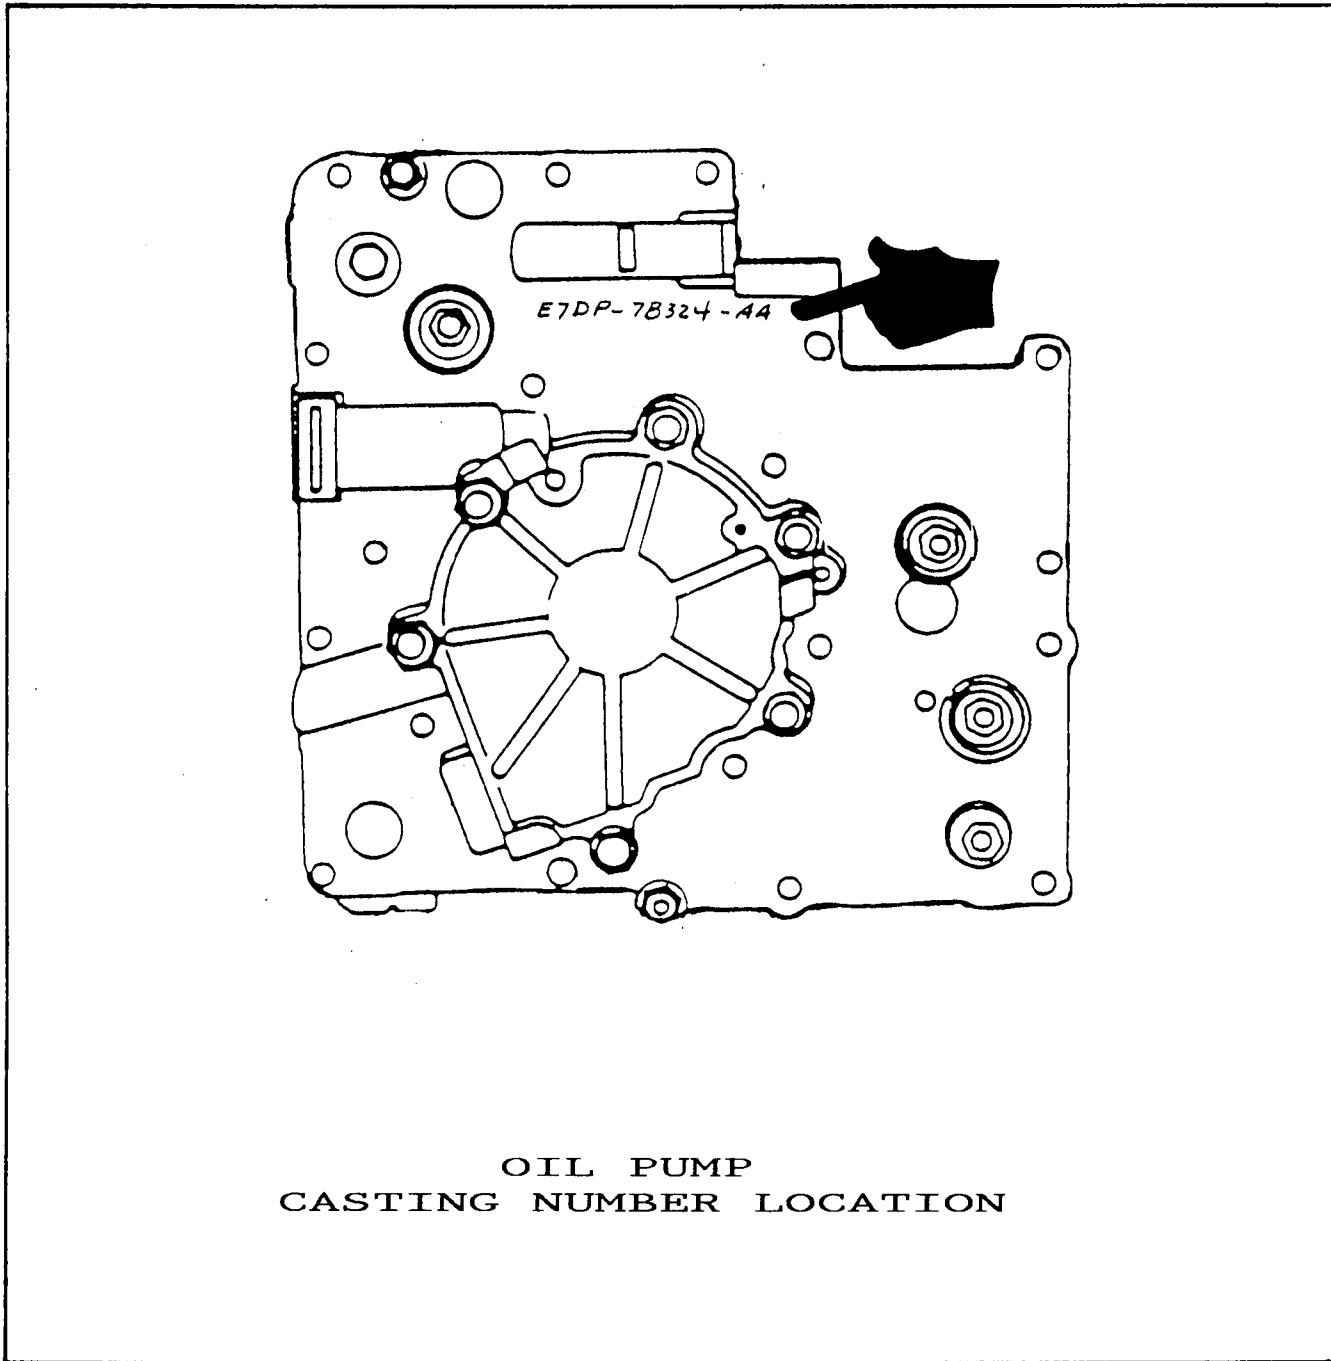
Figure 1

- (1) OIL PUMP CASTING - Must be identified by the casting number located on the pump as shown in Figure 1, and can be identified as follows:
  - E6SP-7B324-AA = 1986 Hydraulics.
  - E7DP-7B324-AA = 1987 Hydraulics.
  - E8DP-7B324-AA = 1988 Hydraulics.
  - E9OP-7B324-AA = 89/90 Hydraulics (10 Checkball Pump).

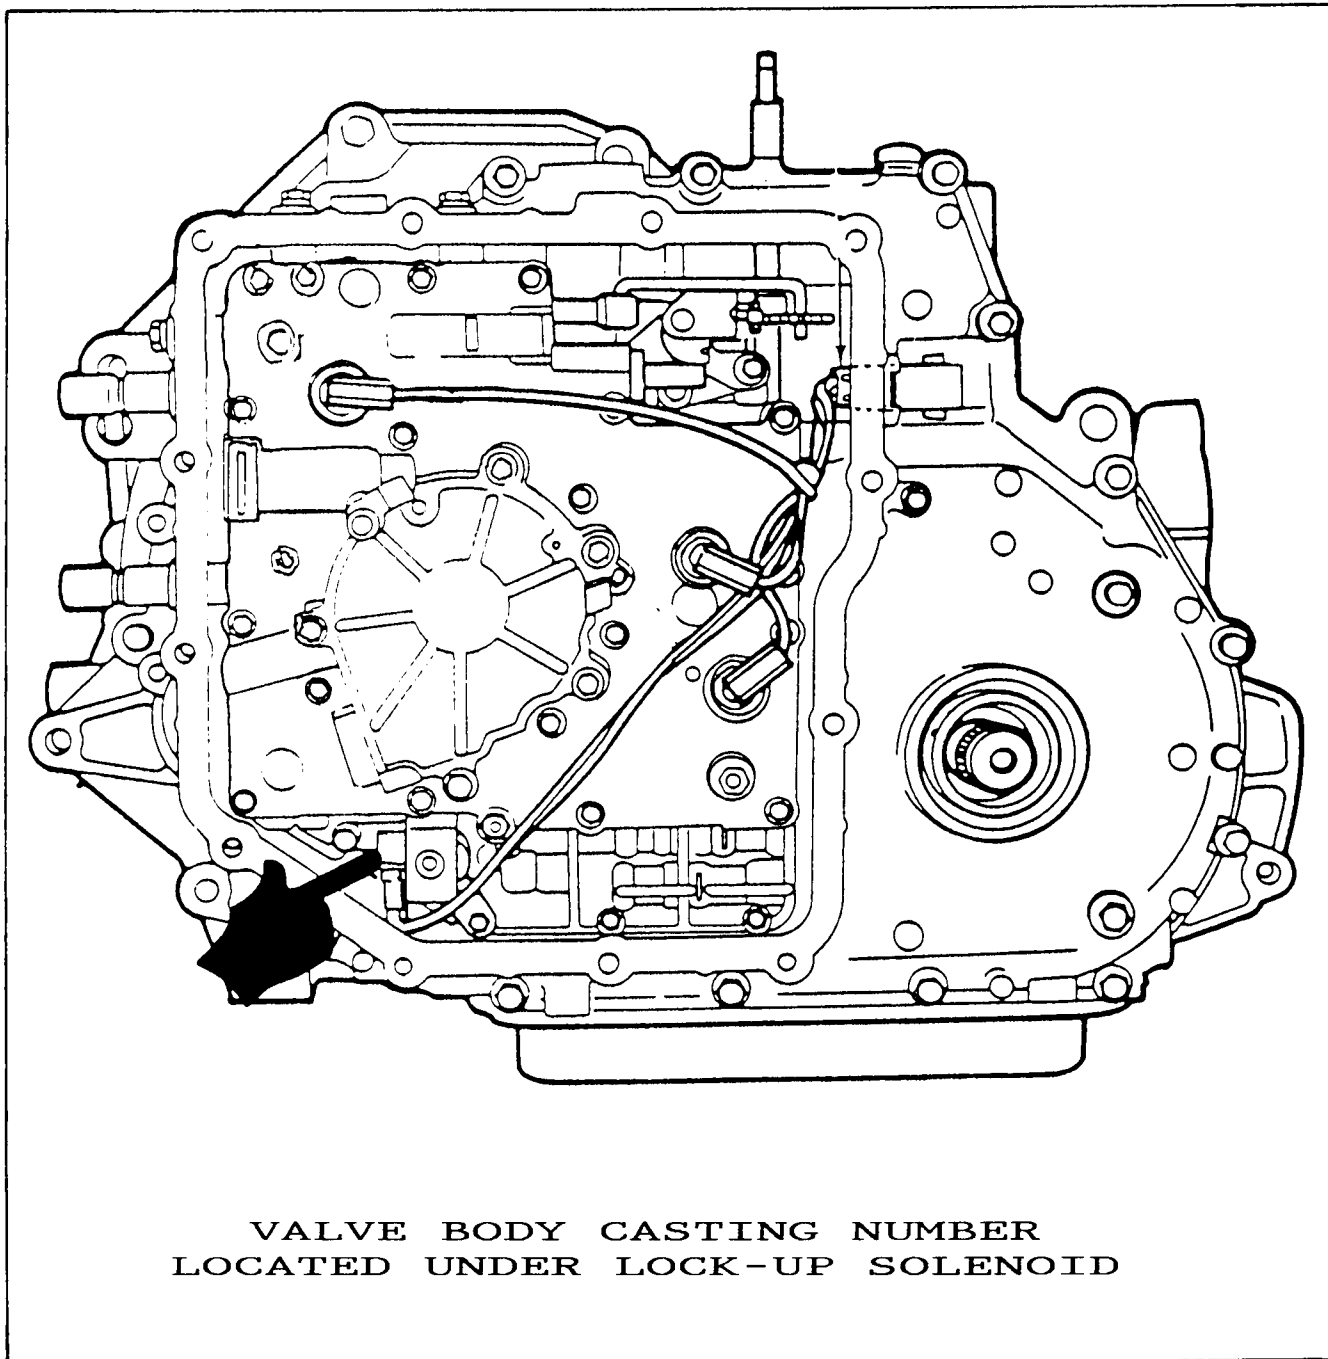
Figure 2

NOTE: Some 1987 models had 1986 pumps, but had 1987 spacer plate, and requires 1987 pump spacer plate gaskets.
- (4) VALVE BODY CASTING - Must be identified by the casting number located beneath the lock-up solenoid as shown in Figure 2, and can be identified as follows:
  - E6SP-7A092-AD = 1986 Hydraulics Only.
  - E7DP-7A092-BA = 1987 Hydraulics Only.
  - E8DP-AA = 88/90 Hydraulics Only.

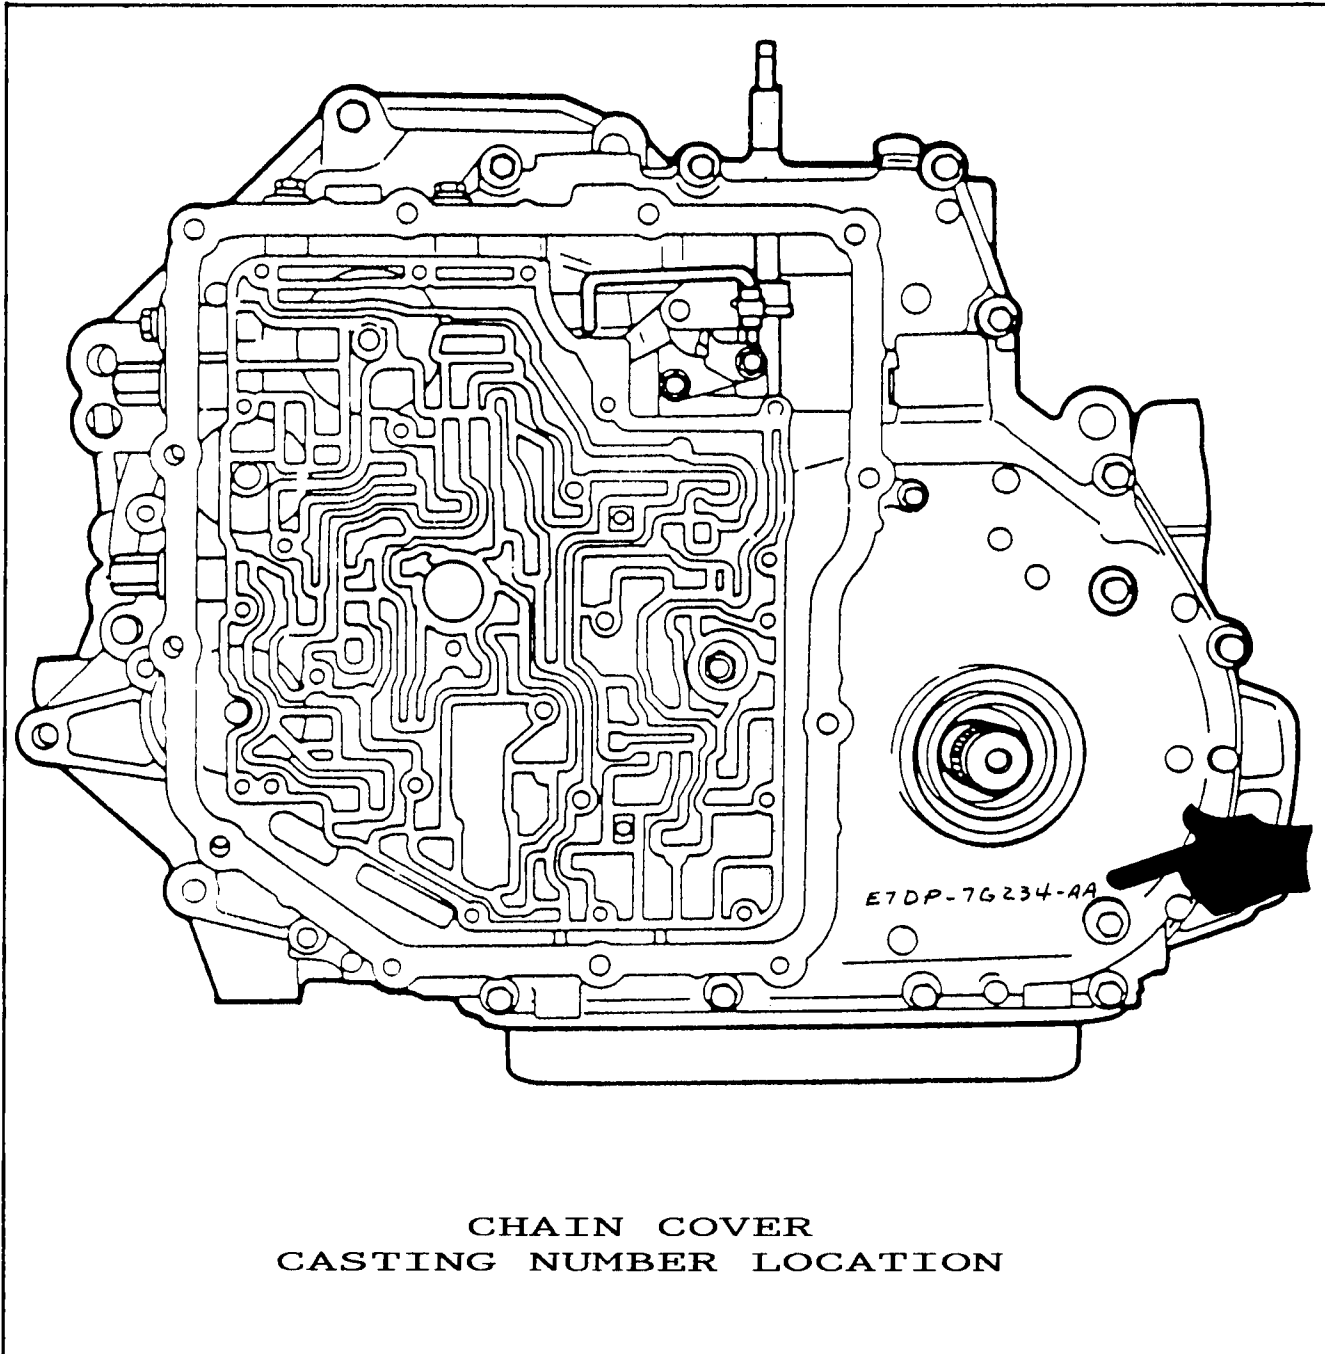
Figure 3

- (7) CHAIN COVER - Must be identified by the casting number located below the axle seal as shown in Figure 3, and can be identified as follows:
  - E6SP-7G234-AA = 1986 Hydraulics Only.
  - E7DP-7G234-AA = 1987 Hydraulics Only.
  - E8DP-7G234-AA = 88/90 Hydraulics Only.
- (8) OIL PUMP CHECKBALL LOCATIONS - The 1986 through 1989 oil pumps have 9 checkballs, and locations are shown in Figure 16. Some 1989 models and all 1990 model oil pumps have 10 checkballs, and locations are shown in Figure 17.

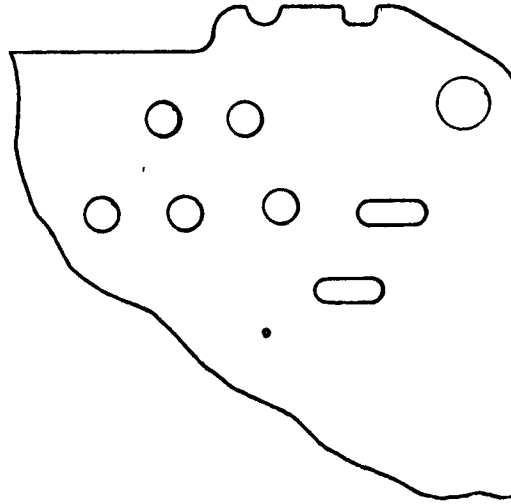
Figure 7

SPACER PLATES WILL NOT INTERCHANGE FROM MODEL TO MODEL

THIS SPACER PLATE FITS "ONLY" THE 10 CHECKBALL OIL PUMP.

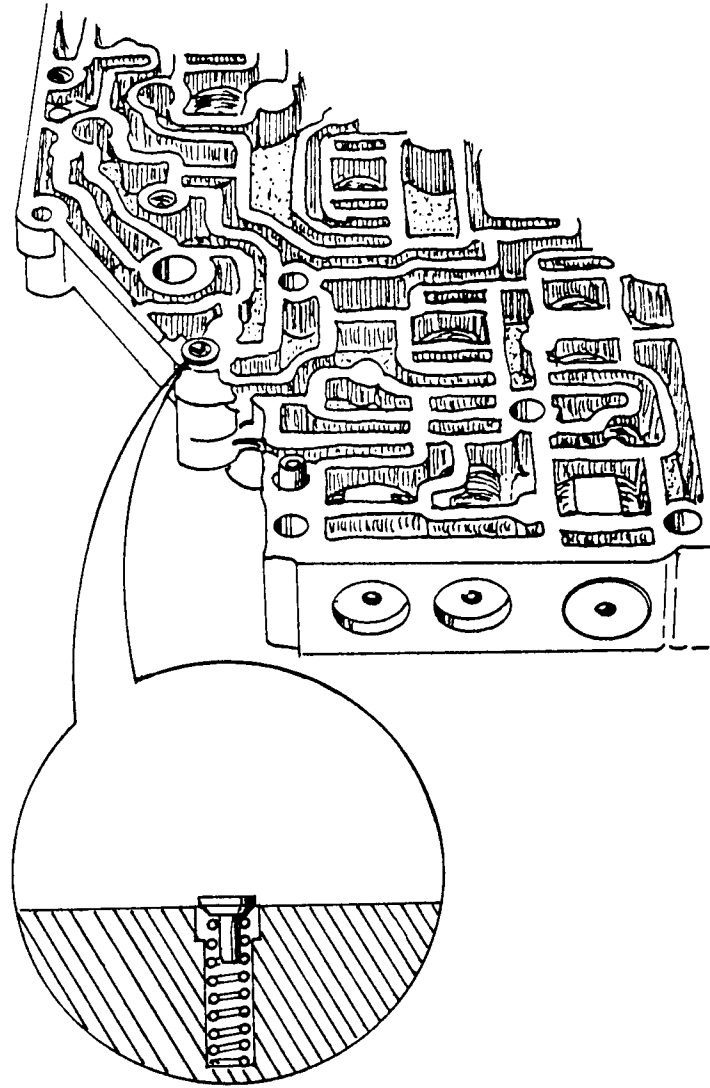
Figure 28

TRIM THE REAR LUBE CHECK VALVE SPRING, UNTIL THE CHECK VALVE SITS ABOUT 1/16" ABOVE THE MACHINED SURFACE OF VALVE BODY.

2. Trim the rear lube check valve spring, which is located in the valve body, until the check valve sits approximately 1/16" above the machined surface of the valve body (See Figure 28). This will require approximately 3 coils be removed from the spring, and always install the cut end of the spring back into the valve body first.

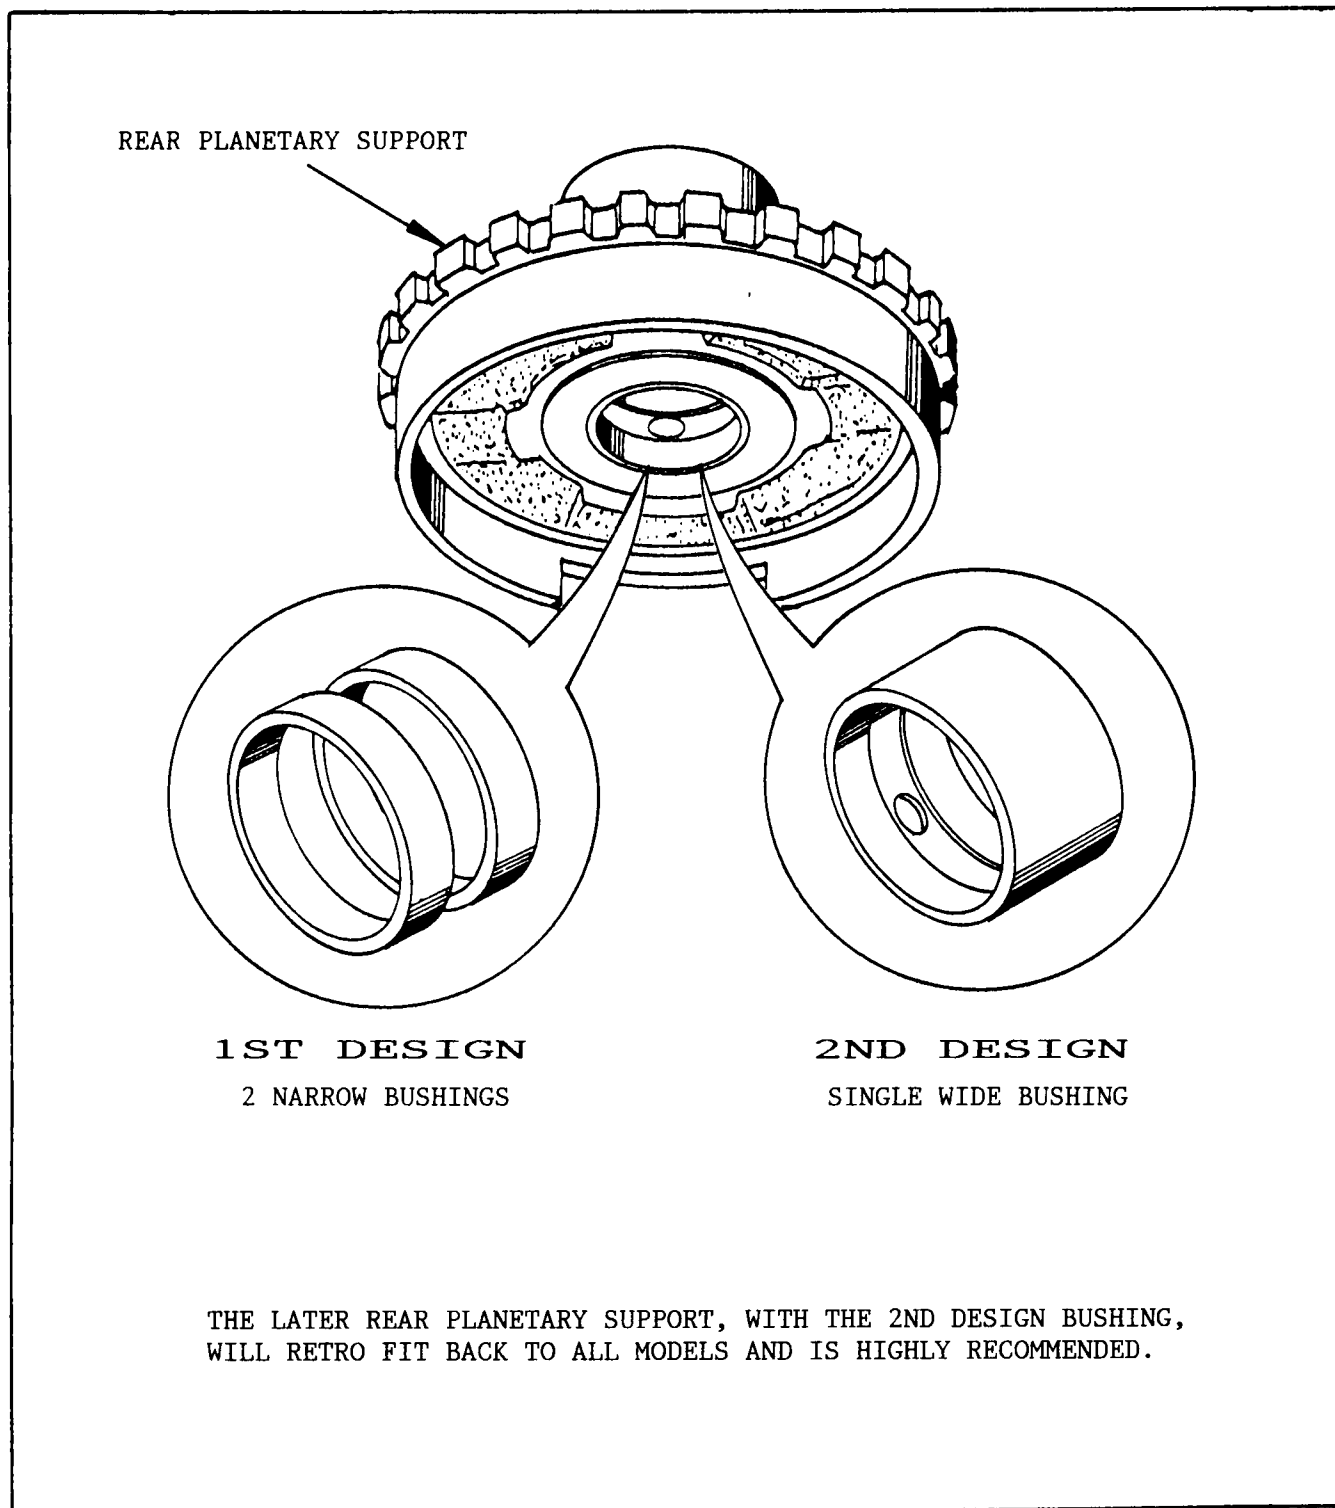
Figure 29

3. Inspect the bushings in the rear planetary support, as these bushings can move out of position and block the lube oil hole located in the support between them. The 1988 and later rear planetary support has a new design, wider, one piece bushing with a groove and lube hole in the center. This will provide more surface area to prevent the bushing from moving. Refer to Figure 29.

The later rear planetary support, with the 2nd design bushing, will retro fit back to ALL previous models and is highly recommended. The new design rear planetary support is available under OEM part number E6DZ-7A130-A.

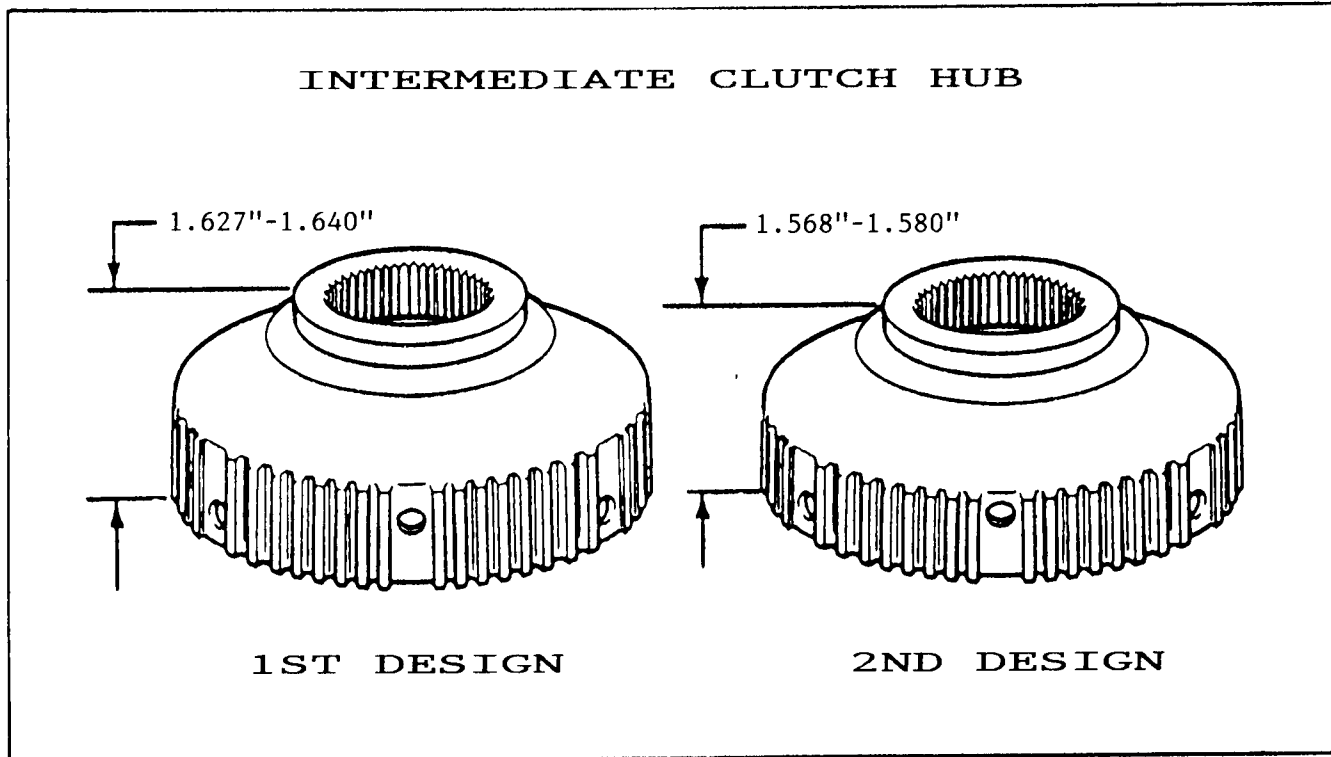
Figure 32

- (2) **INTERMEDIATE CLUTCH HUB** - Overall height was made shorter by approximately .060" with no identifying marks. The hub **MUST** be measured with a dial caliper or depth gage.  
The 1st design hub will measure 1.627"-1.640", and the 2nd design hub will measure 1.568"-1.580" as shown in Figure 32.

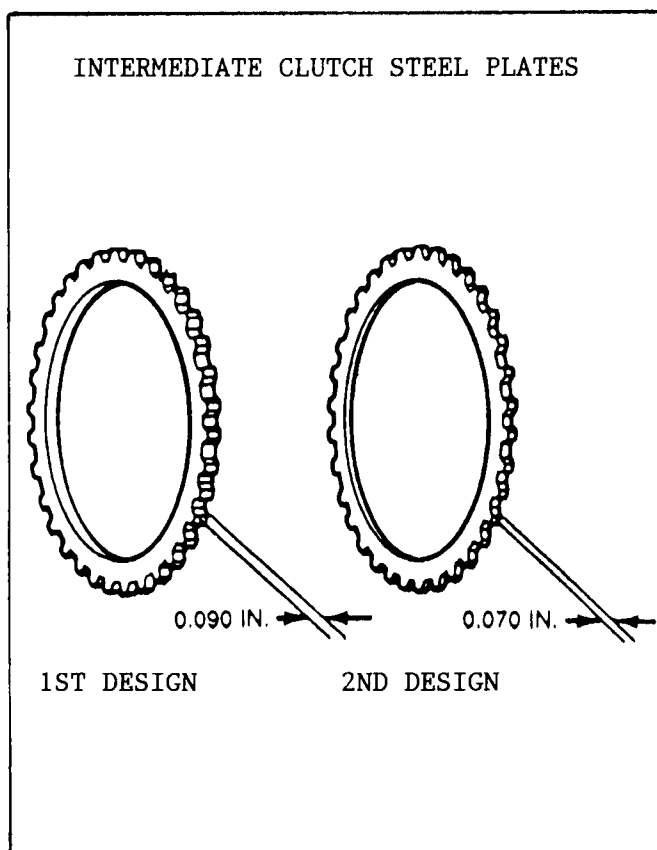
Figure 33

- (3) **INTERMEDIATE CLUTCH STEEL PLATES** - Thickness was reduced by .020" to help accommodate the added wave plate on 3.8L models, or the added spacer plate on 3.0L models.  
The 1st design steel plates are .090" thick, and the 2nd design steel plates are .070" thick as shown in Figure 33.

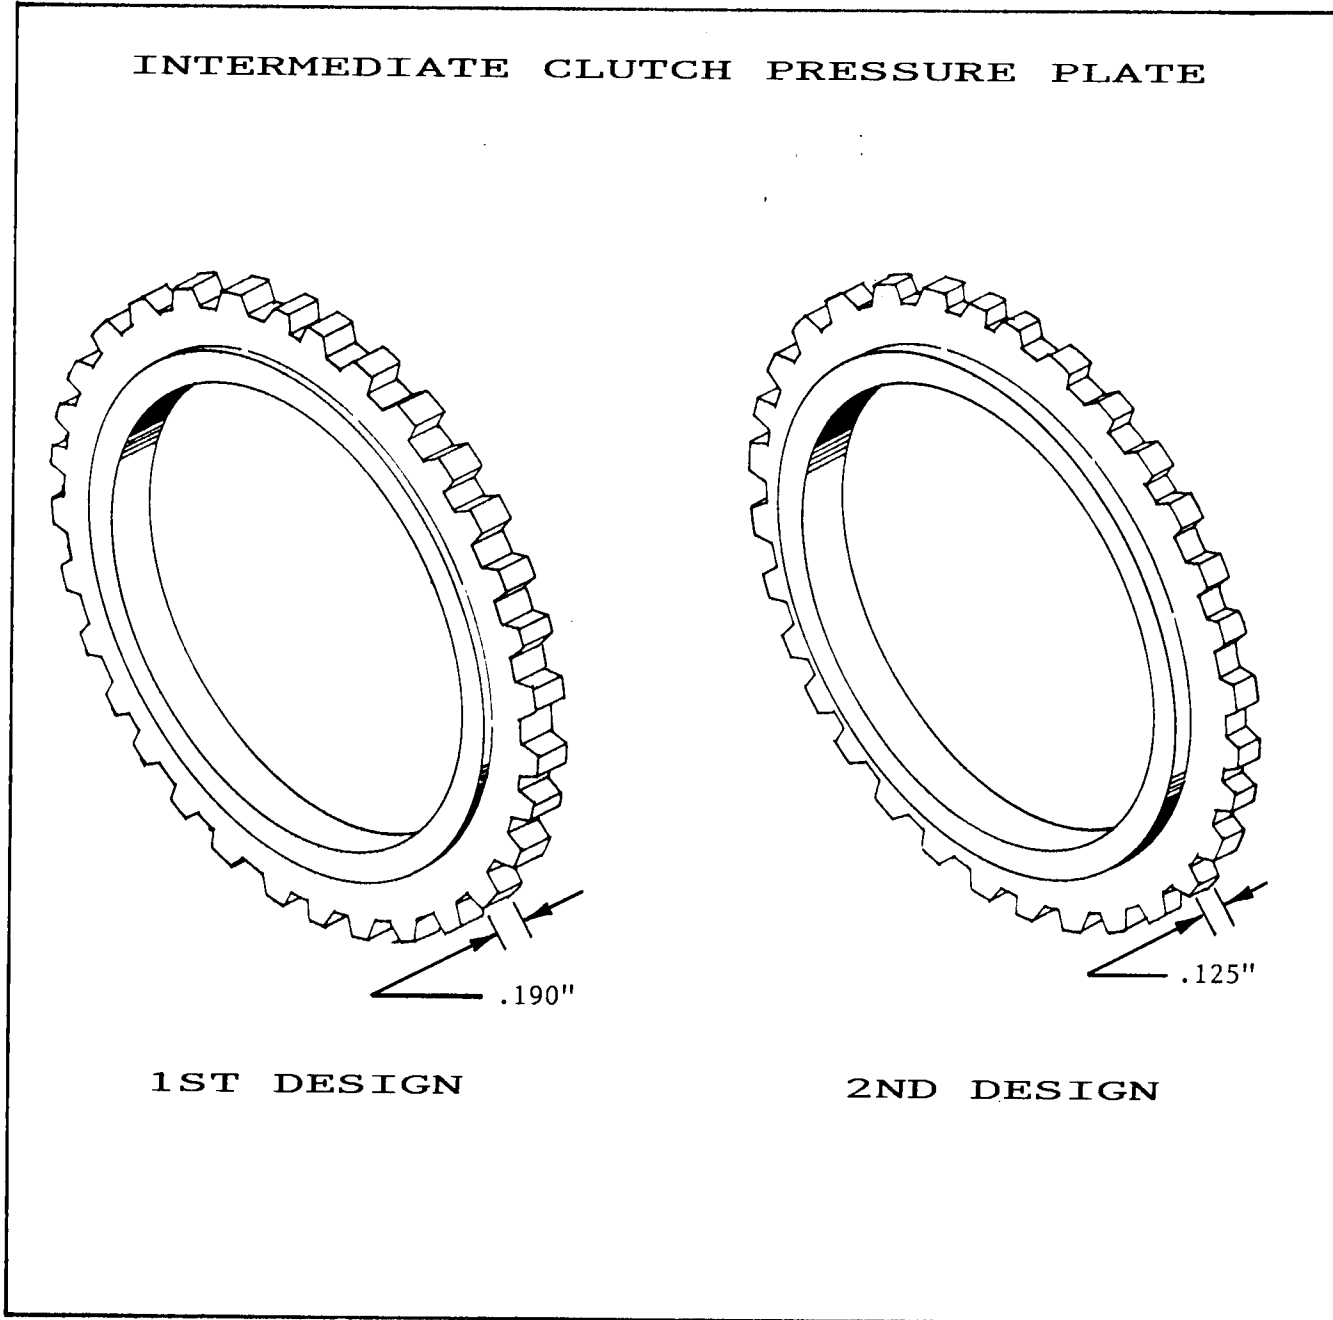
Figure 35

- (4) **INTERMEDIATE CLUTCH PRESSURE PLATE** - Thickness was reduced by .065" to help accommodate the added wave plate on 3.8L models, or the added spacer plate on 3.0L models.  
The 1st design pressure plate is .190" thick, and the 2nd design pressure plate is .125" thick as shown in Figure 35.

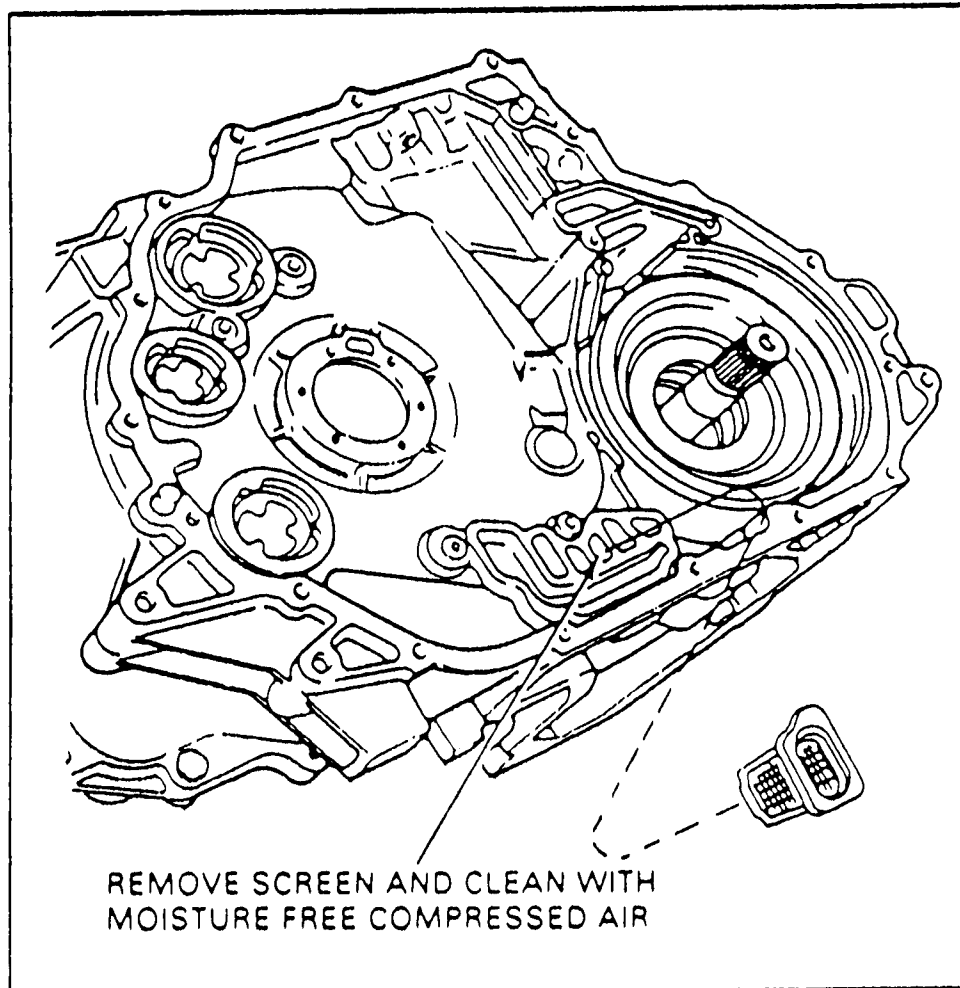
Figure 38

CHANGE: A new filter has been added to the 1989 AXOD 1-2 servo apply circuit as shown in Figure 38.

NOTE: A no forward condition could occur if the filter becomes contaminated.

New Filter ..... E9DZ-7H162-A

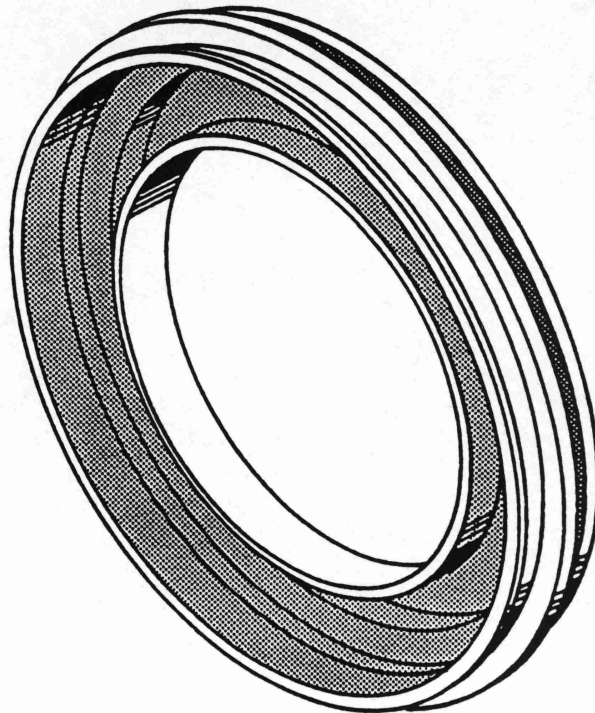
Figure 39

**CHANGE:** The Forward Clutch Piston material has now been changed to "Steel", instead of the previous design aluminum piston, as shown in Figure 39.

**REASON:** To eliminate cracks from occurring in the seal groove and greatly improve durability.

- (1) FORWARD CLUTCH PISTON - Now manufactured out of steel, instead of aluminum, and there are no dimensional changes on the piston (See Figure 39).

Forward Clutch Piston (All Except "SHO" Models) ..... F4DZ-7A262-A  
Forward Clutch Piston (3.2L "SHO" Models Only) ..... F4DZ-7A262-B

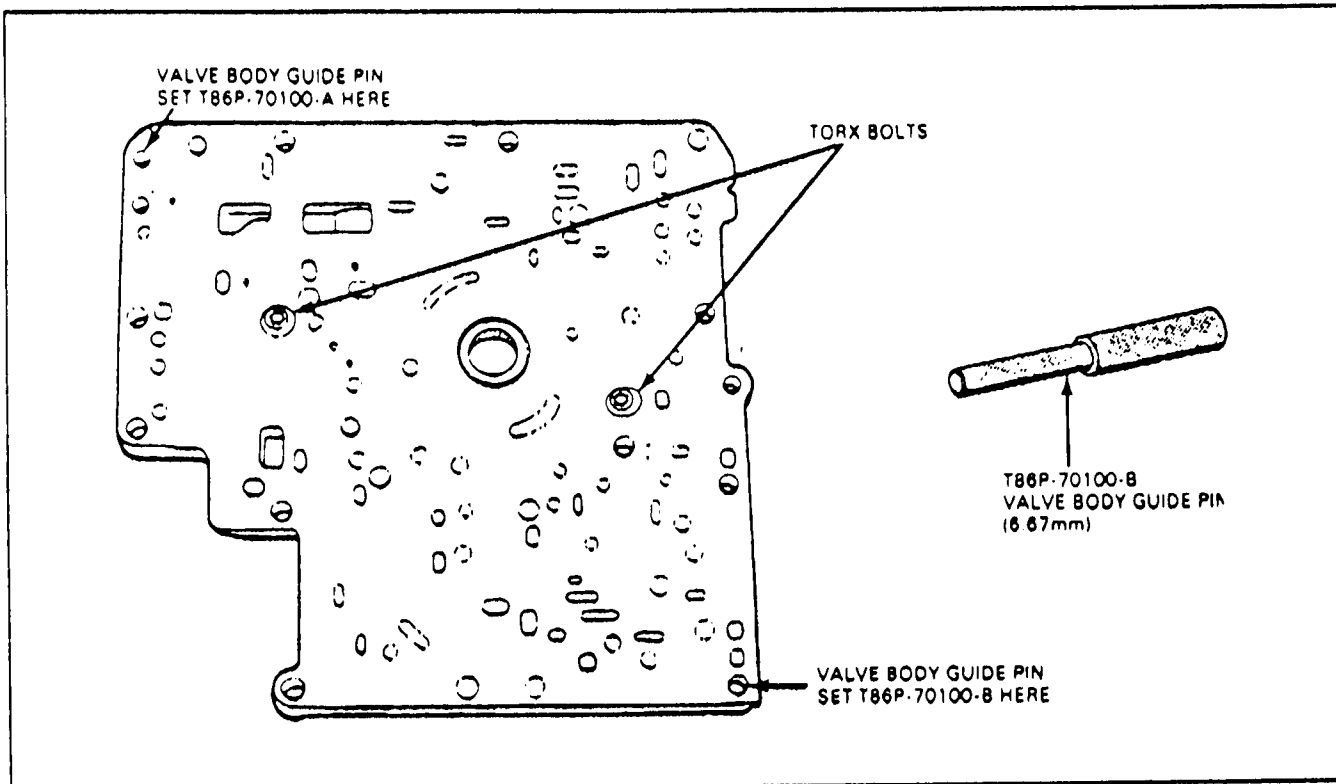
Figure 44

### WEAR ON OIL PUMP SHAFT AND BEARING

Proper alignment of the oil pump and the valve body are mandatory to prevent premature wear of the oil pump drive shaft and the bearing assembly located in the pump housing. When re-assembling the valve body and oil pump, use the guide pins to assure proper alignment.

1. Position the spacer plate on the pump housing, using a new gasket.
2. Insert valve body guide pin T86P-70100-A (.271" Diameter) and valve body guide pin T86P-70100-B (.262" Diameter), as shown in Figure 44.
3. Install two "Torx" bolts and torque to 7 to 9 ft.lb.
4. Remove both guide pins.
5. Position the spacer plate on the valve body using a new gasket.
6. Insert two valve body guide pins T86P-70100-A (.271" Diameter), as shown in Figure 45.
7. Install two "Torx" bolts and torque to 7 to 9 ft.lb.
8. Position the oil pump on the valve body using a new gasket.
9. Insert pump body guide pin T86P-70370-A and valve body guide pin T86P-70100-C which is .245" in Diameter.
10. Install two valve body to oil pump retaining bolts and torque to 7 to 9 ft.lb.

Oil Pump Drive Shaft .....	E6DZ-7B328-A
Pump Bearing With Integral Seal .....	XF2Z-7G184-AA
Pump Body Guide Pin .....	T86P-70370-A
Valve Body Guide Pin (.271" Dia. - 2 Required) .....	T86P-70100-A
Valve Body Guide Pin (.262" Dia.) .....	T86P-70100-B
Valve Body Guide Pin (.254" Dia.) .....	T86P-70100-C

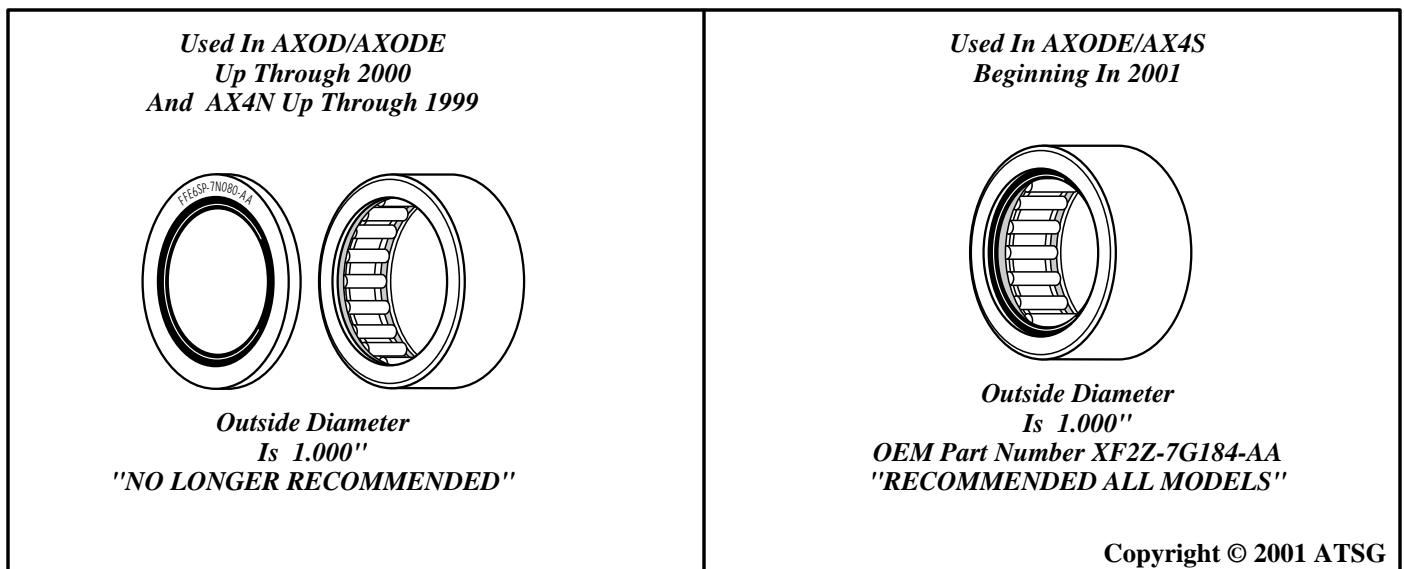
Figure 47

**CHANGE:** Beginning at the start of production for 2001 on all AX4S transaxles, Ford Motor Company introduced a new design pump bearing that includes an integrated seal, as shown in Figure 47. When this new design bearing and seal assembly went into production, it was installed with the *seal on the valve body side of the pump instead of the rotor side.*

**REASON:** Greatly reduced pump bearing, pump rotor and vane ring failure, for much improved durability and reliability.

Pump Bearing With Integral Seal ..... XF2Z-7G184-AA

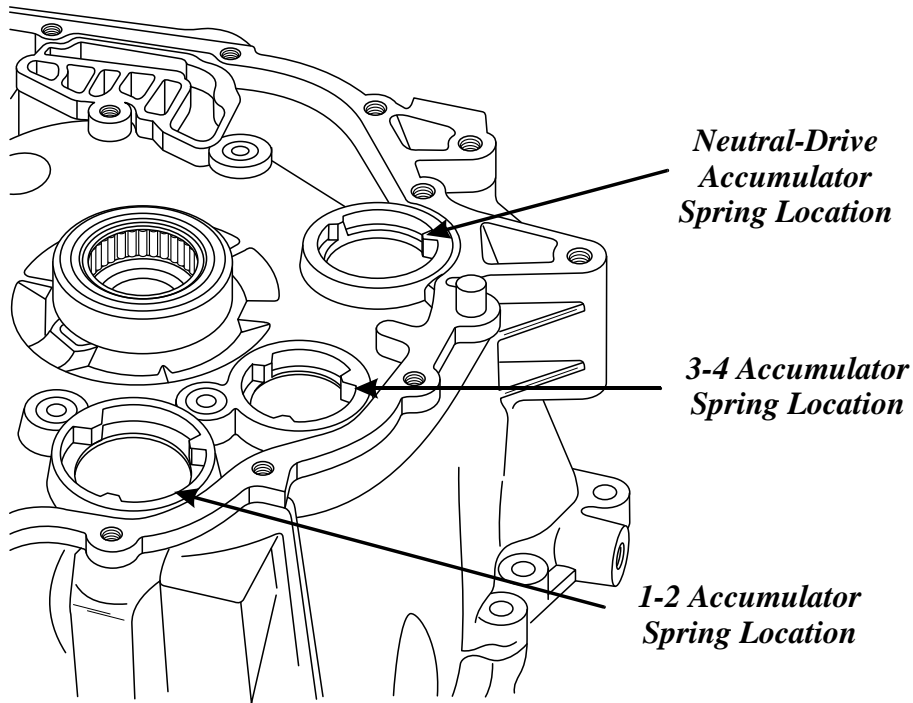
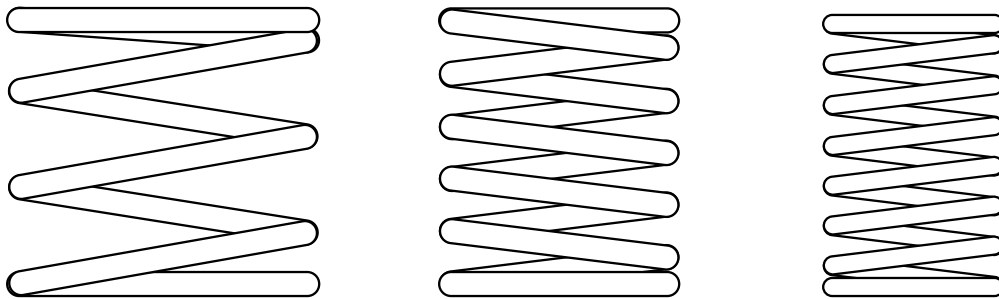
**CAUSE:** The accumulator springs may have been installed in incorrect positions, or the accumulator piston shafts are scored or worn and are interfering with proper accumulator piston movement. It is also important to insure that multiple accumulator spring applications must have the springs wound in opposite directions of each other to avoid coil bind, as shown in Figure 49.

**SPRINGS ARE WOUND OPPOSITE OF EACH OTHER TO AVOID COIL BIND**

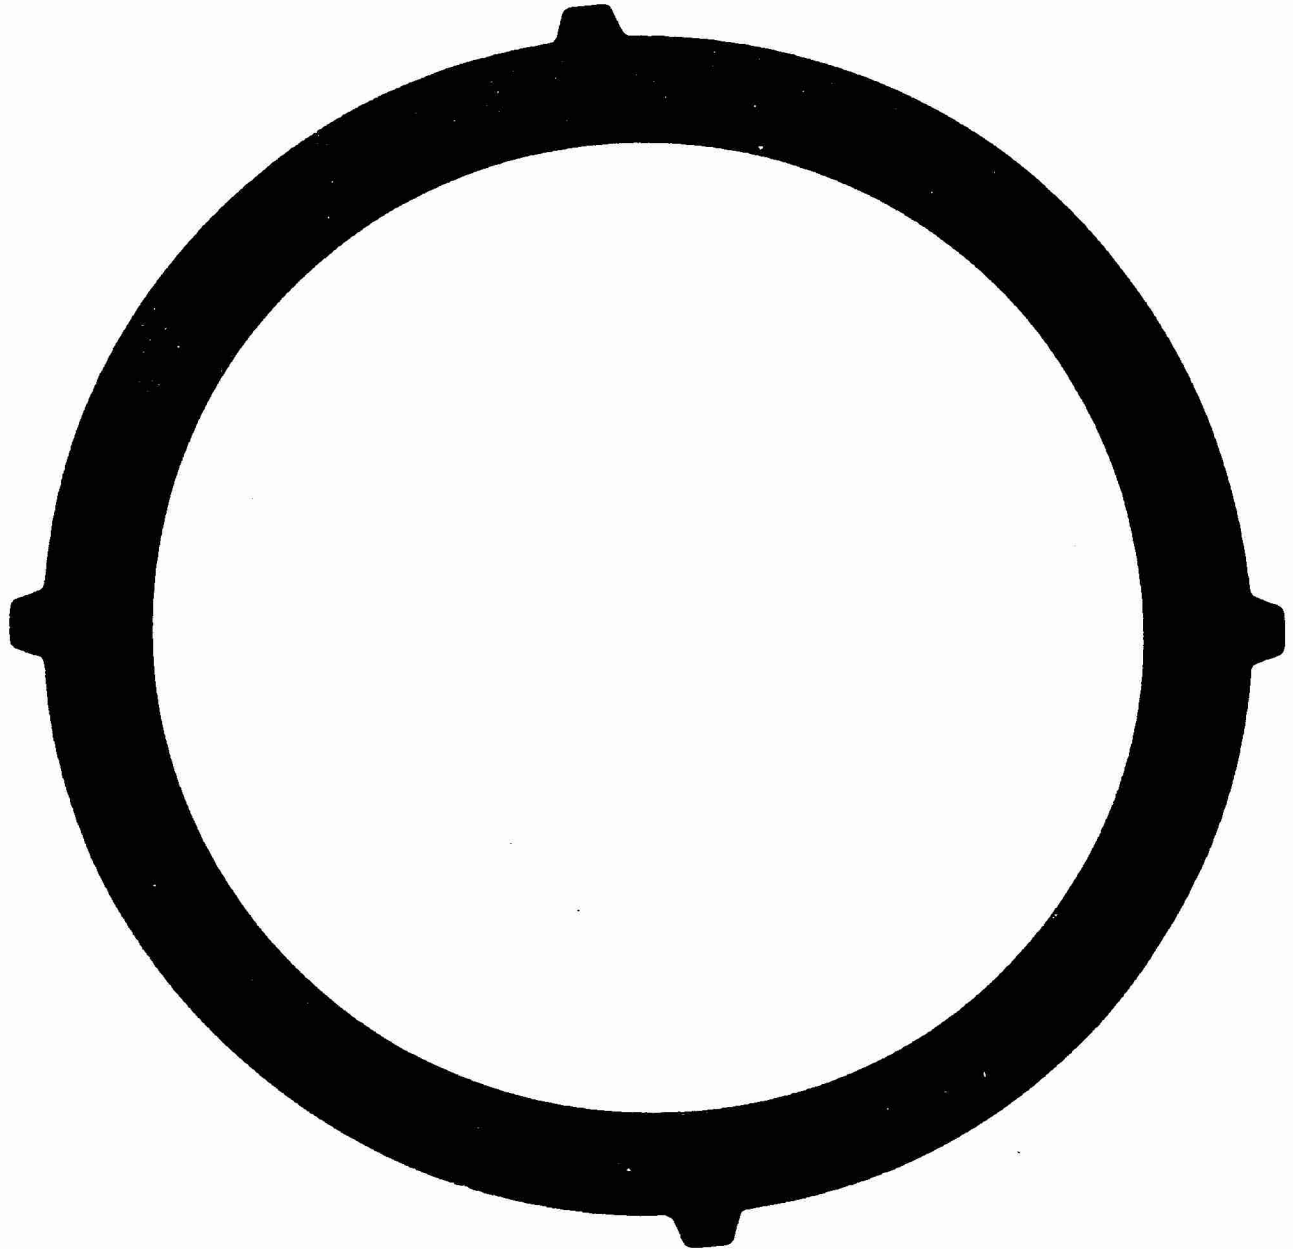
Figure 54

1ST DESIGN - Has 4 external teeth, an inside diameter of 4.715", material thickness of .062", and was used from 1986-1988. Refer to Figure 54.

*4 External Teeth  
Inside Diameter 4.715"  
Material Is .062" Thick  
Part Number E6DZ-7E085-B*

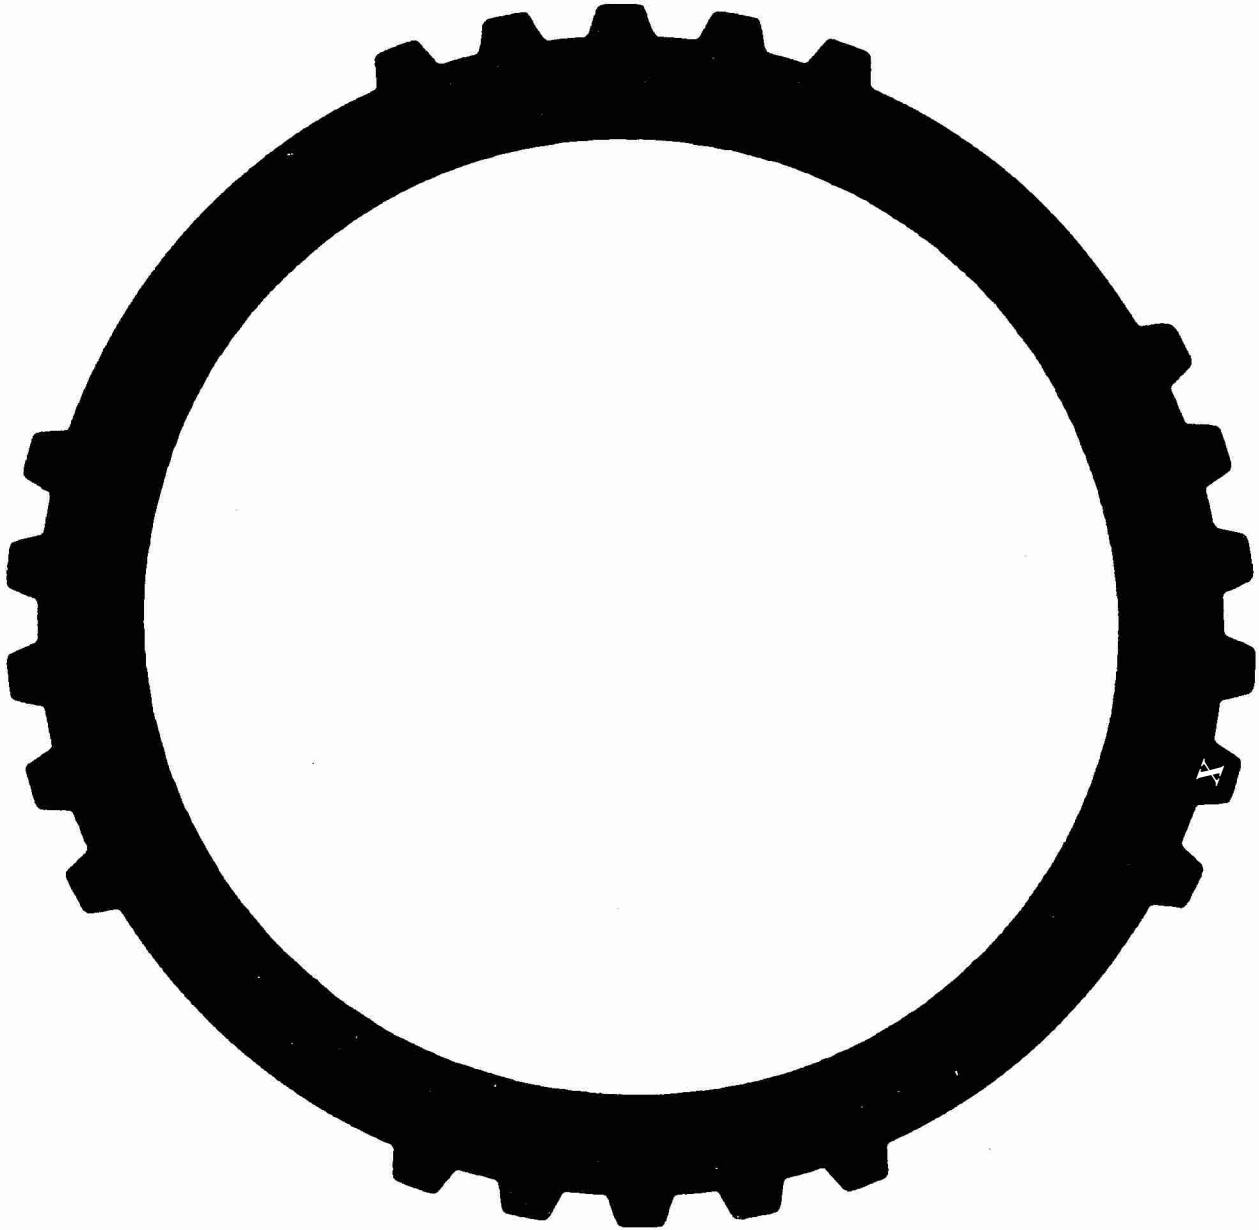
Figure 55

2ND DESIGN - Has 21 external teeth, inside diameter of 4.730", material thickness of .075", identified with letter "X" stamped on 1 tooth, and was used from 1989-1991. (See Figure 55).

*21 External Teeth  
Inside Diameter 4.730"  
Material Is .075" Thick  
I.D. Stamped "X" On 1 Tooth  
Part Number F0DZ-7E085-A*

The 2nd design forward clutch wave plate will retro-fit back to all previous models and is the recommended wave plate for the AXOD transaxle.

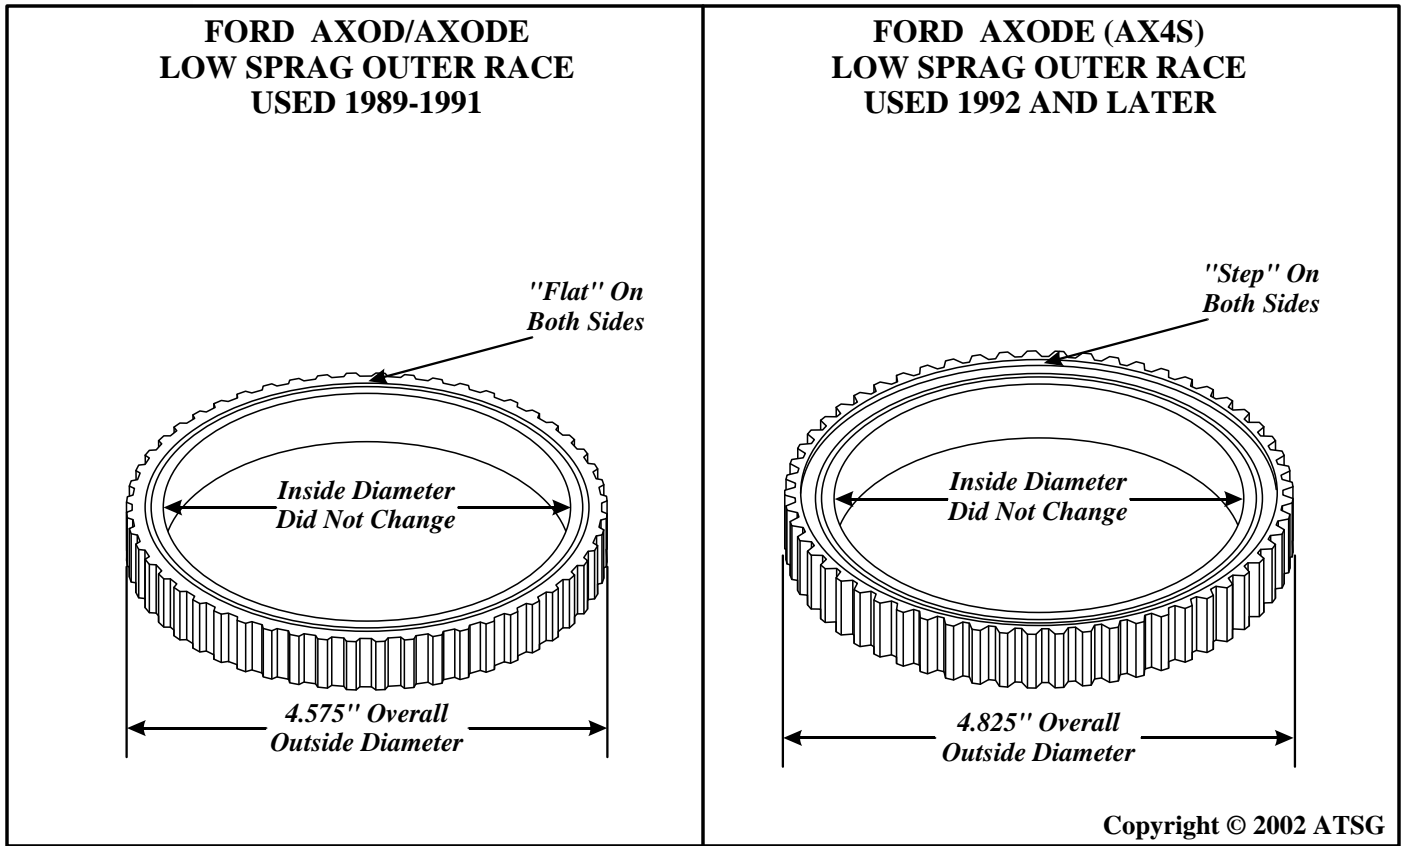
Figure 57

- (1) LOW SPRAG OUTER RACE - The outer diameter of the race was increased from 4.575" to 4.825", and the width of the race was increased from .600" to .725", as shown in Figure 57. *The Inside Diameter of the sprag race Did Not Change.*
