# AXOD/AXODE (AX4S) UPDATE HANDBOOK

*Updated  
October, 2002*

Since the introduction of the Ford AXOD transaxle in model year 1986, there have been many major engineering design changes that have affected many of the parts used in the AXOD transaxle. This version of the AXOD "Update Handbook" begins with the 1986 model year and will explain each change, the parts affected by the change, and any parts interchange problems created by the change. This booklet is an updated version of the original.

This updated version of the AXOD "Update Handbook" will also cover the changes that occurred in the 1991 model year, when electronic controls were adapted to the AXOD transaxle, making it an AXODE, and now called an AX4S transaxle. We have included the changes on the AX4S transaxle up through and including model year 2002.

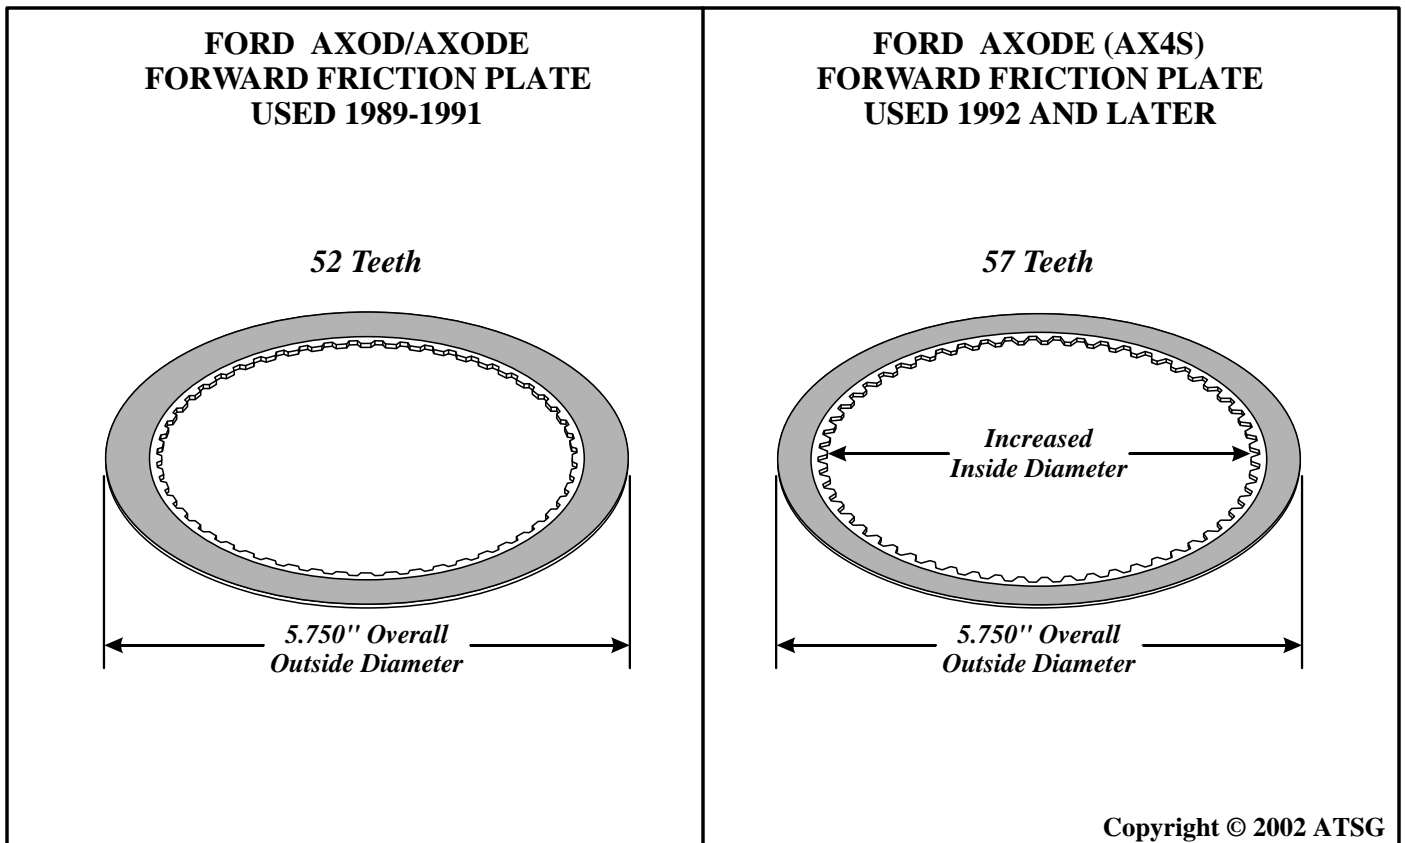
Figure 58

- (2) FORWARD CLUTCH FRICTION PLATES - Have an increased amount of teeth to 57 Teeth from the previous 52 Teeth, to accommodate the increased diameter of the sprag outer race, as shown in Figure 58.

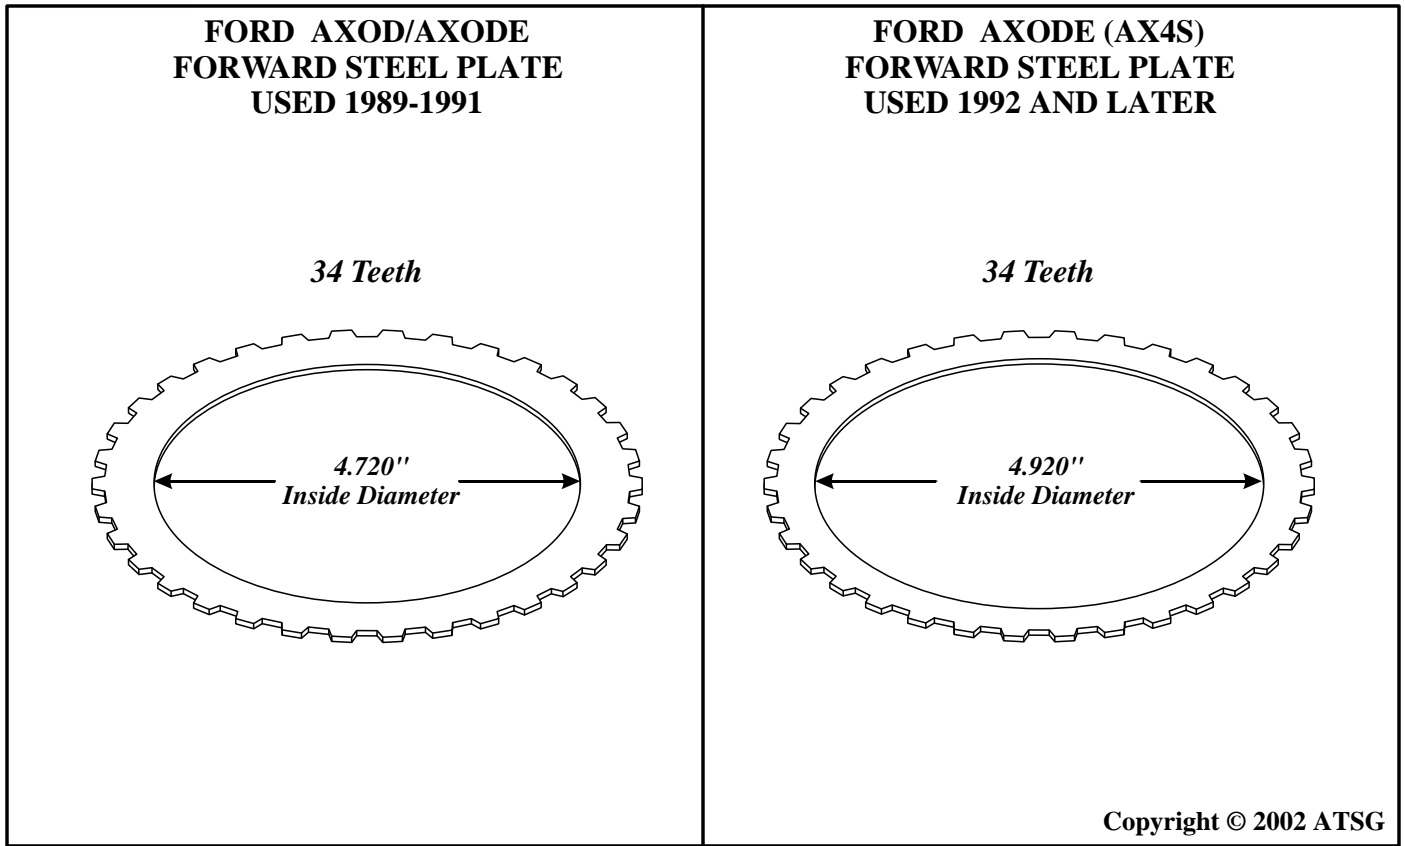
Figure 59

- (3) FORWARD CLUTCH STEEL PLATES - Have an increased inside diameter to 4.920" from the previous 4.720", to accommodate the increased diameter of the sprag outer race, as shown in Figure 59.

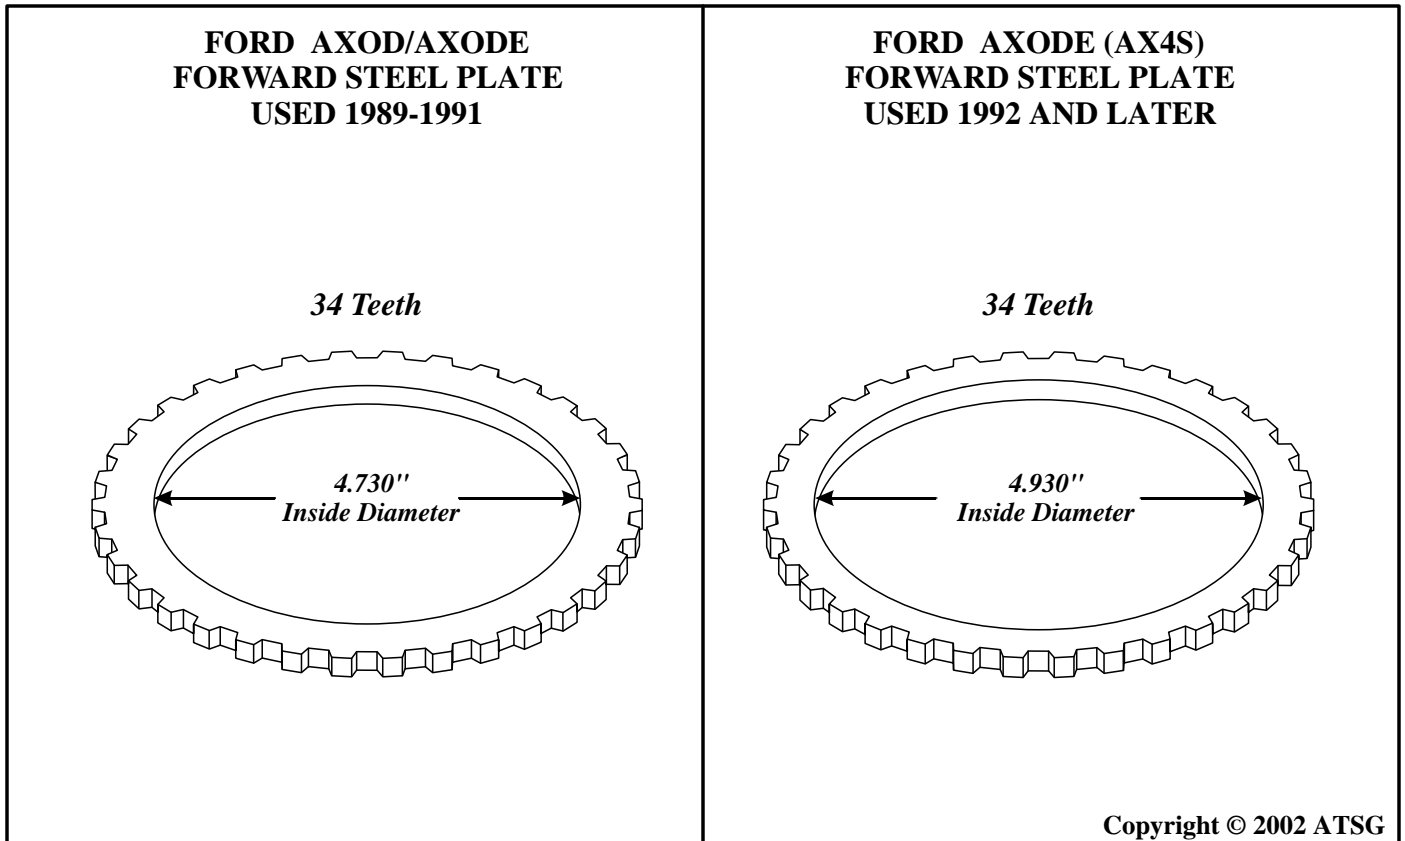
Figure 60

- (4) FORWARD CLUTCH PRESSURE PLATE - Has an increased inside diameter to 4.930" from the previous 4.730", to accommodate the increased diameter of the sprag outer race, as shown in Figure 60.

Forward Clutch Friction Plates (2nd Design) .....	F2DZ-7B164-A
Forward Clutch Steel Plates (2nd Design) .....	F2DZ-7B442-A
Forward Clutch "Wave" Plate (2nd Design) .....	F2DZ-7E085-A
Forward Clutch Pressure Plate (2nd Design) .....	F2DZ-7B066-A
Forward Clutch Overhaul Kit (Includes Low Sprag Outer Race) .....	F2DZ-7D171-A

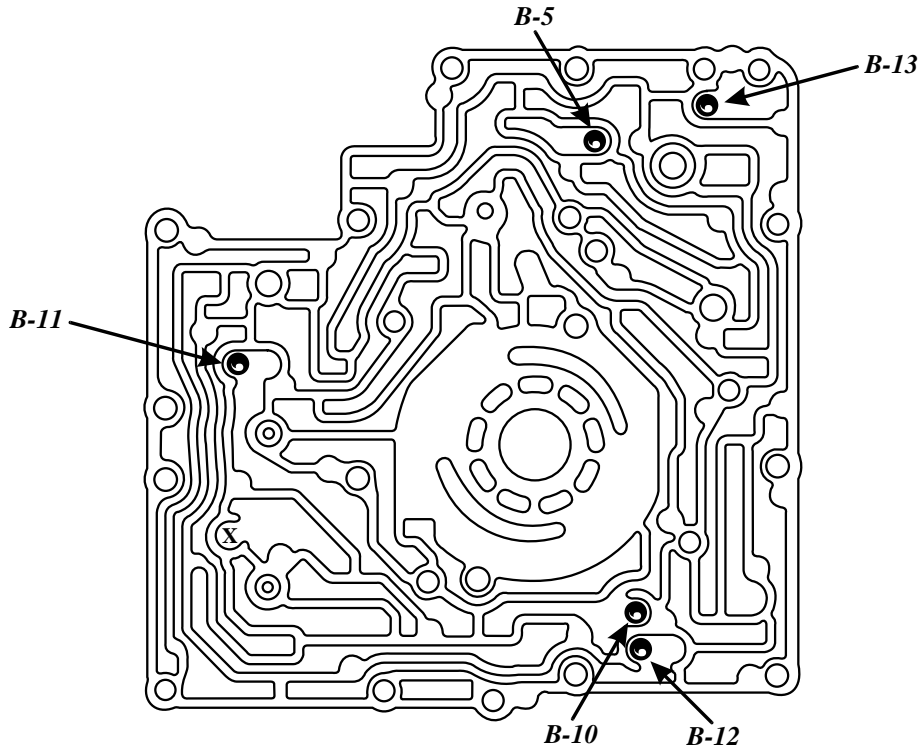
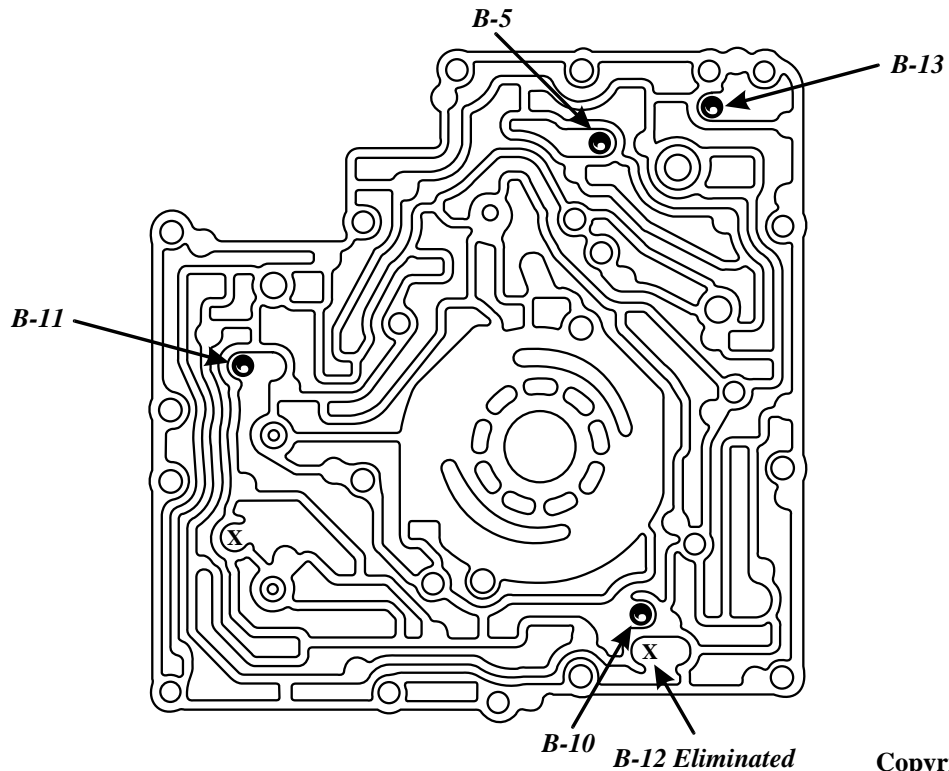
Figure 65

*"Early" 1991 Only - Uses 5 checkballs in the locations shown in Figure 65. Use chart above to determine Early or Late transaxle by serial number.*

*"Late" 1991 Only - Uses 4 checkballs in the locations shown in Figure 65. Use chart above to determine Early or Late transaxle by serial number.*

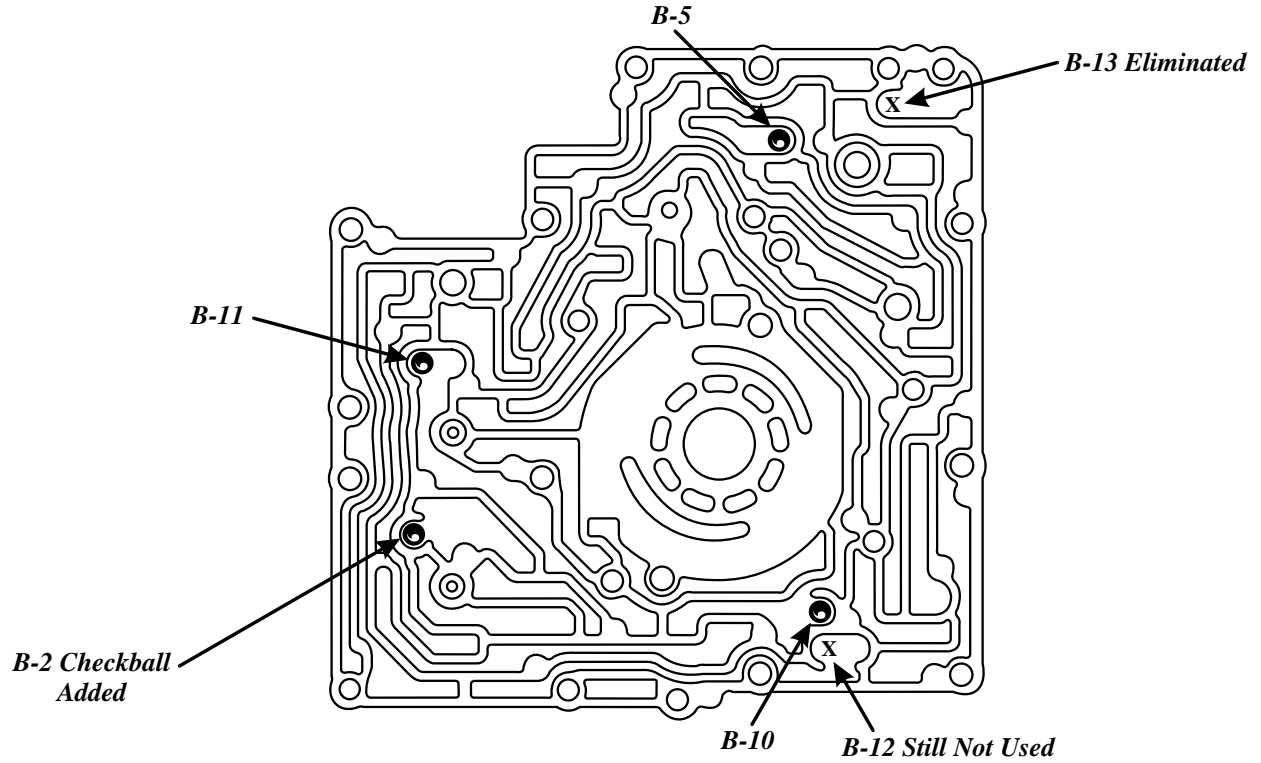
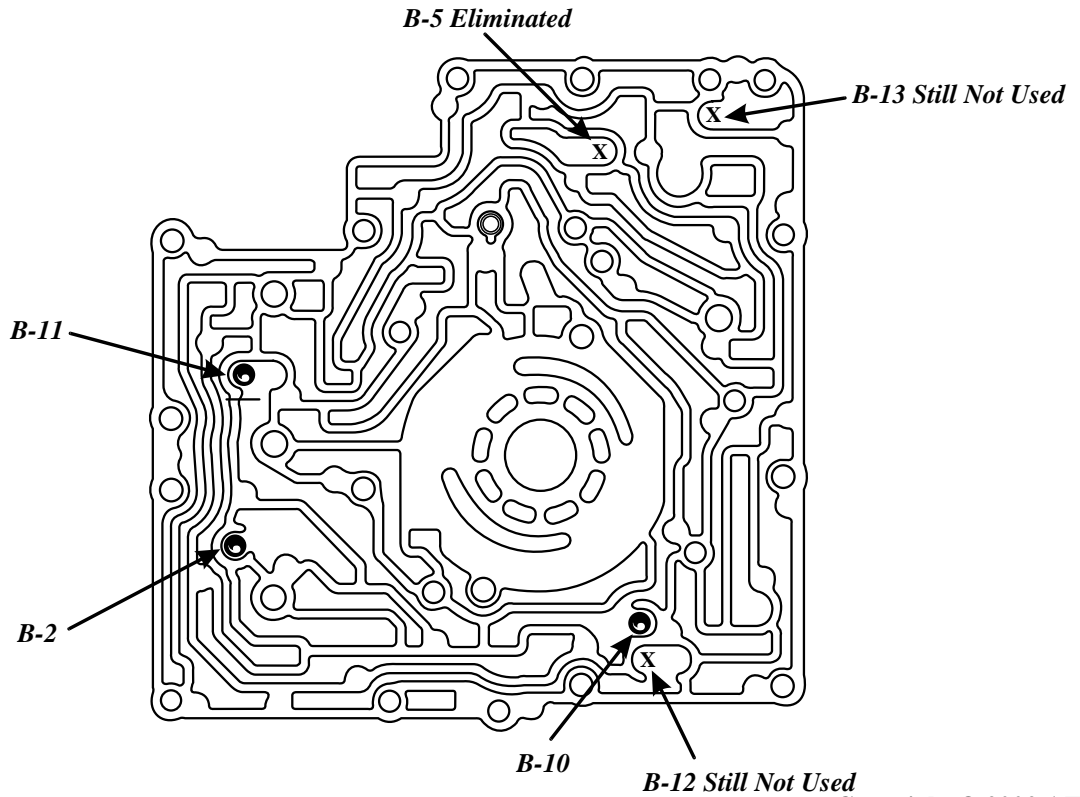
Figure 66

*1992-1998 Only - Uses 4 checkballs but in different locations, as shown in Figure 66. B-13 checkball was eliminated and B-2 checkball was added.*

*1999-2002 Only - Uses 3 checkballs in the locations shown in Figure 66. B-5 checkball was eliminated.*

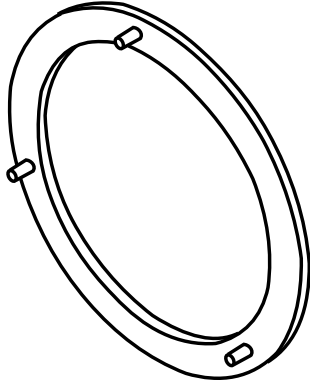
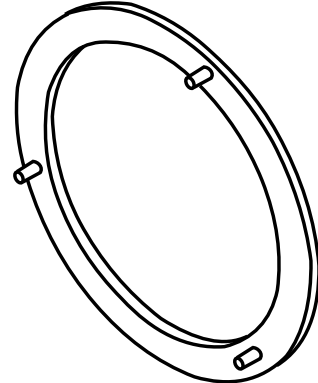
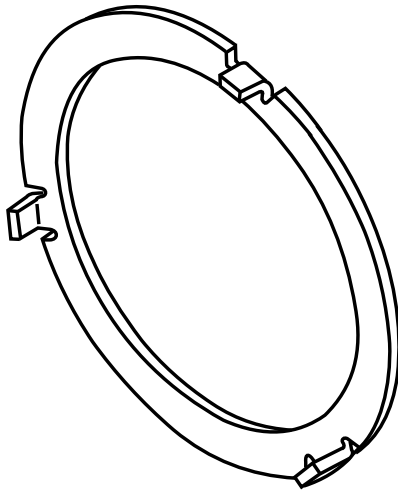
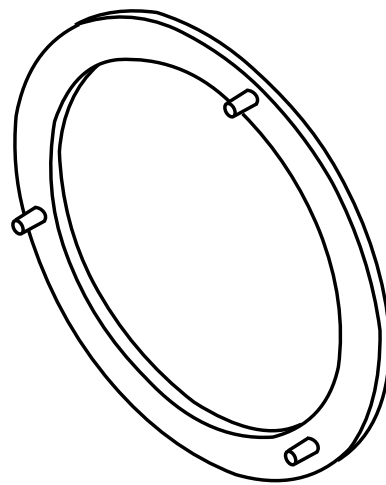
Figure 84

**CHANGE:** Beginning on October 13, 1995, introduced as a running change for 1996 models, the AX4S transaxles were built with new design Number 1 and Number 3 thrust washers (See Figure 84).

**NUMBER 1 THRUST WASHER  
WITH NON-SYMETRICALLY LOCATED TABS  
PART NUMBER E6DZ-7G099-A**

**NUMBER 1 THRUST WASHER  
WITH SYMETRICALLY LOCATED TABS  
PART NUMBER F5DZ-7G099-A**

**NUMBER 3 BRONZE THRUST WASHER  
WITH TANGS ON OUTSIDE DIAMETER  
PART NUMBER E6DZ-7G096-A**

**NUMBER 3 PLASTIC THRUST WASHER  
WITH SYMETRICALLY LOCATED TABS  
PART NUMBER F5DZ-7G096-A**

If replacement of the number 1 and/or the number 3 thrust washer becomes necessary, inspect the chain cover in the thrust washer tab areas to determine the correct thrust washers required. Refer to Figures 85 and 86.

Number 1 Thrust Washer (Before 10/13/95) .....	E6DZ-7G099-A
Number 3 Thrust Washer (Before 10/13/95) .....	E6DZ-7G096-A
Number 1 Thrust Washer (On or After 10/13/95) .....	F5DZ-7G099-A
Number 3 Thrust Washer (On or After 10/13/95) .....	F5DZ-7G096-A

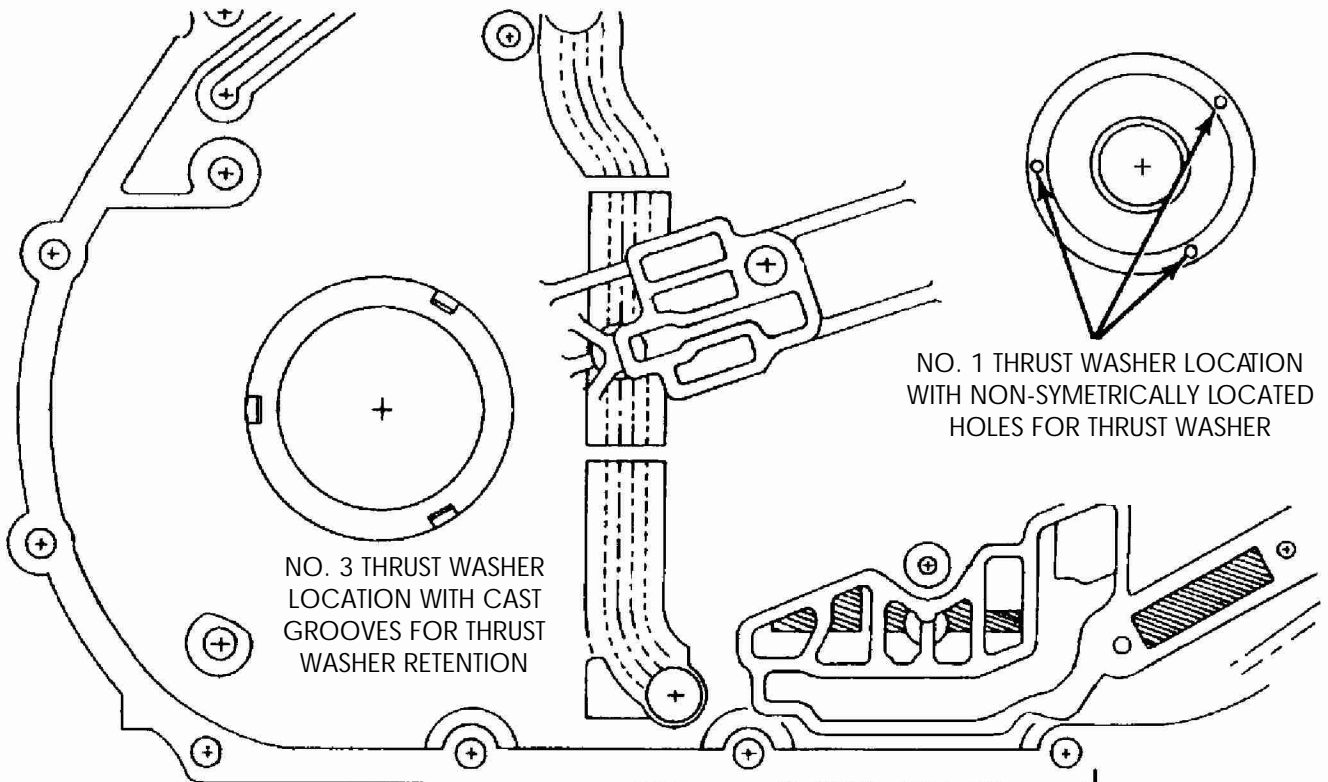
REQUIRES THE PLASTIC NO. 1  
THRUST WASHER WITH TABS THAT  
ARE NON-SYMETRICALLY LOCATED  
PART NUMBER E6DZ-7G099-A

NO. 3 THRUST WASHER  
LOCATION WITH CAST  
GROOVES FOR THRUST  
WASHER RETENTION

NO. 1 THRUST WASHER LOCATION  
WITH NON-SYMETRICALLY LOCATED  
HOLES FOR THRUST WASHER

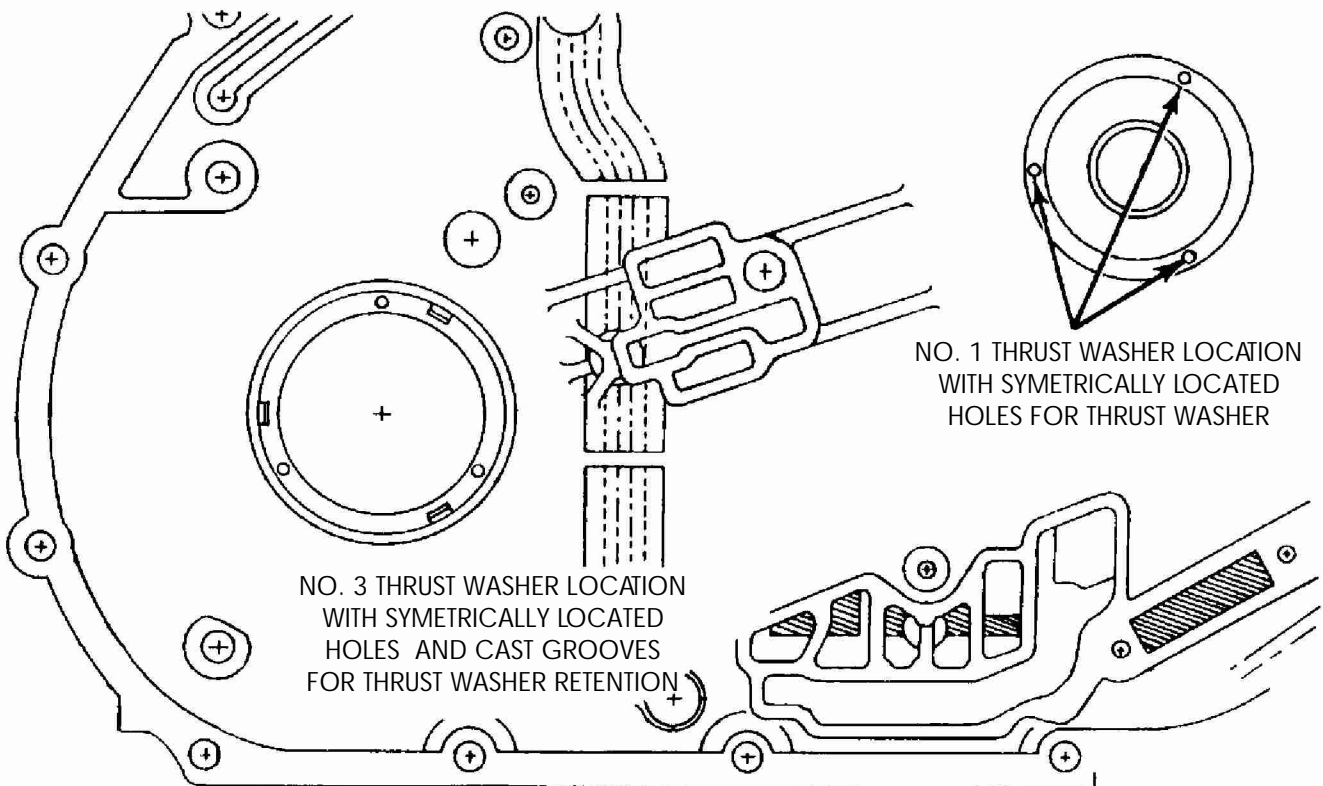
Figure 86

REQUIRES THE PLASTIC NO. 1  
THRUST WASHER WITH TABS THAT  
ARE SYMETRICALLY LOCATED  
PART NUMBER F5DZ-7G099-A

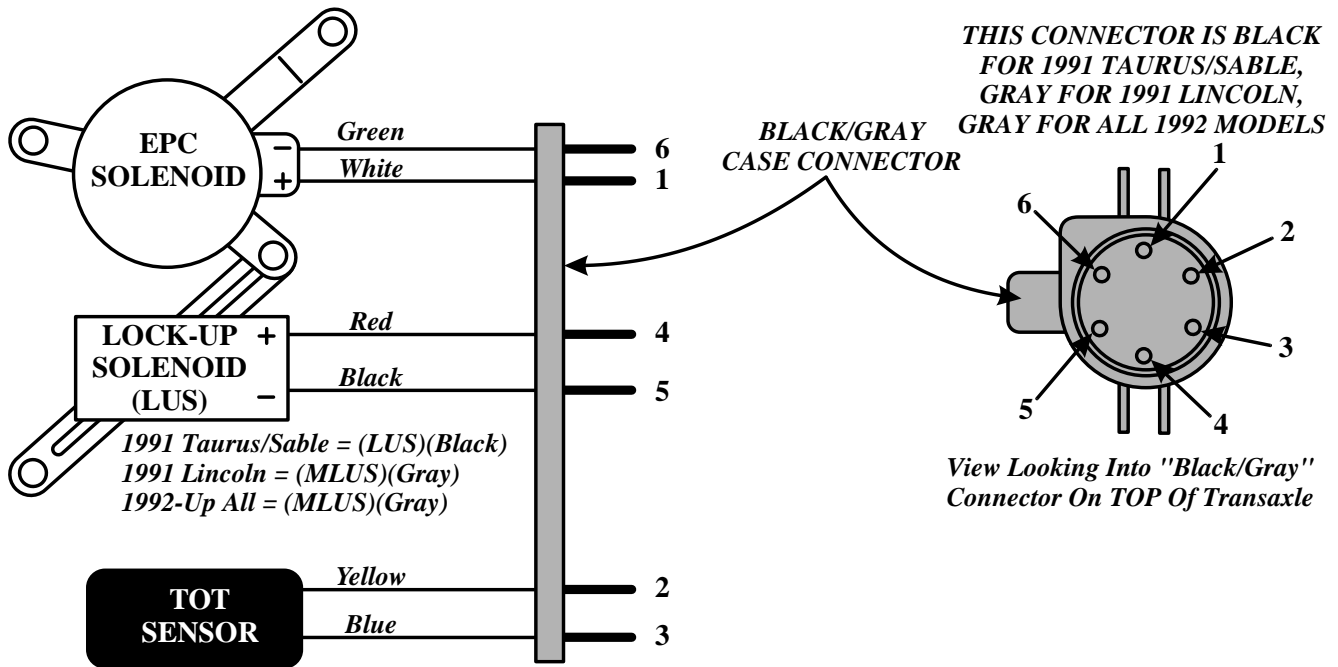
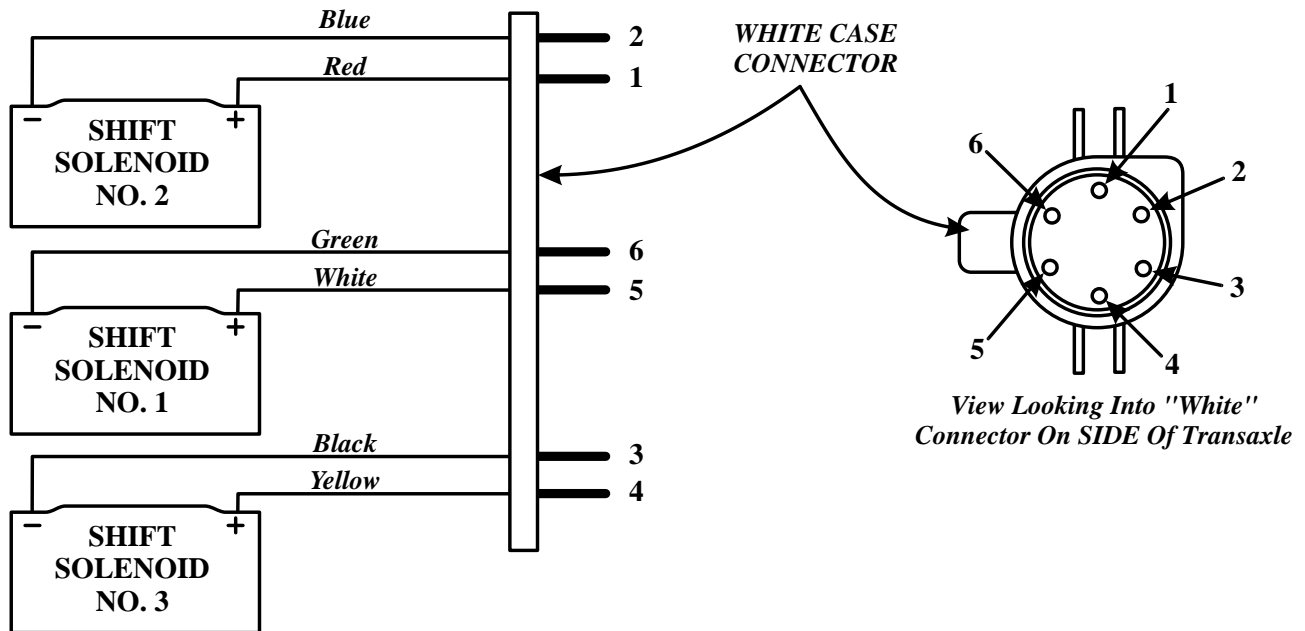
Figure 88

Wires for the Electronic Pressure Control solenoid are fed through pins 1 and 6 of the "Black/Gray" case connector, located on top of the transaxle (See Figure 88). Ohmmeter across terminals 1 and 6 should read 2.5-6.5 Ohms resistance.

Wires for the Modulated Lock-Up Solenoid (MLUS) are fed through pins 4 and 5 of the "Gray" case connector, located on top of the transaxle (See Figure 88). Ohmmeter across terminals 4 and 5 should read 0.75-2.0 Ohms resistance if you have MLUS. The Modulated Lock-Up Solenoid (MLUS) is found on the *Lincoln Only* for the 1991 model year. Taurus/Sable for 1991 are the regular Lock-Up Solenoid (LUS) that is described below. *All models for 1992 model year are MLUS.*

Wires for the Lock-Up Solenoid (LUS) are fed through pins 4 and 5 of the "Black" case connector, located on top of the transaxle (See Figure 88). Ohmmeter across terminals 4 and 5 should read 16-40 Ohms resistance if you have LUS. The Lock-Up Solenoid (LUS) is found on the *Taurus/Sable Only* for the 1991 model year. Lincoln for 1991 is the Modulated Lock-Up Solenoid (MLUS) that is described above. *All models for 1992 model year are MLUS.*

Wires for the Transaxle Oil Temperature (TOT) sensor are fed through pins 2 and 3 of the "Black/Gray" case connector, located on top of the transaxle (See Figure 88). Ohmmeter across terminals 2 and 3 should read the approximate resistance listed in the chart below. Resistance should decrease if transaxle is heated, and should increase if transaxle is allowed to cool. Oil pan that is warm to the touch is about 105°F-158°F.

Wires for Shift Solenoid 1 are fed through pins 5 and 6 of the "White" case connector, located on the side of transaxle (See Figure 88). Ohmmeter across terminals 5 and 6 should read 12-30 Ohms resistance.

Wires for Shift Solenoid 2 are fed through pins 1 and 2 of the "White" case connector, located on the side of transaxle (See Figure 88). Ohmmeter across terminals 1 and 2 should read 12-30 Ohms resistance.

Wires for Shift Solenoid 3 are fed through pins 3 and 4 of the "White" case connector, located on the side of transaxle (See Figure 88). Ohmmeter across terminals 3 and 4 should read 12-30 Ohms resistance.

*The 1991-1992 AXOD-E transaxle has 2 case connectors, 1 Black or Gray in color on the top of the transaxle, and 1 White in color on the side of the transaxle.*

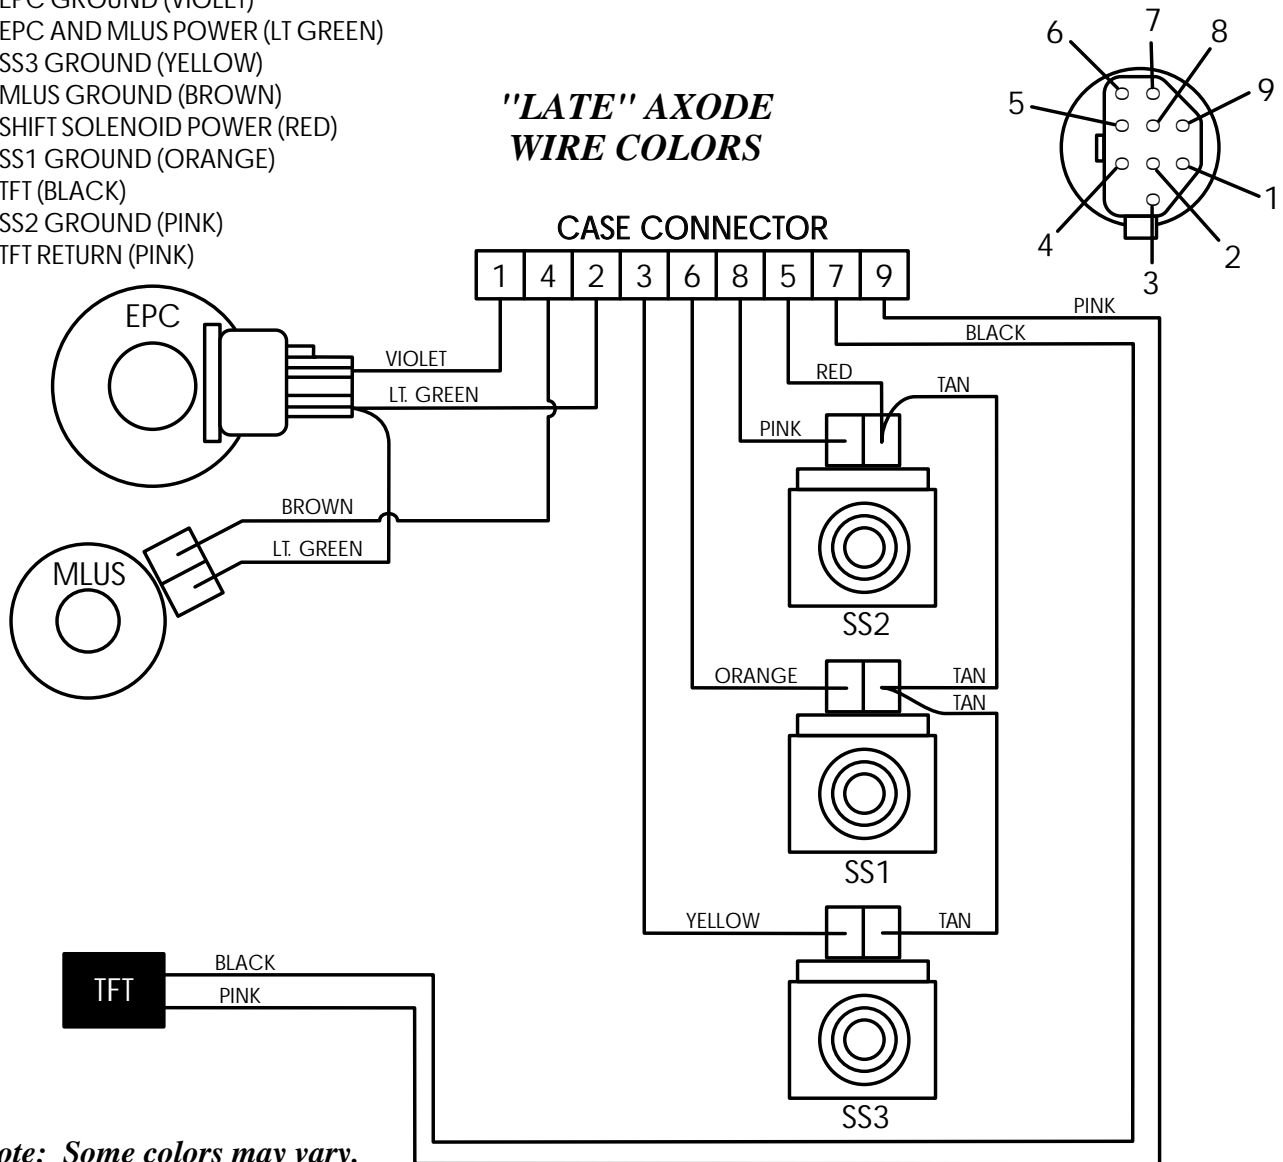
**COMPLAINT:** *After rebuild*, harsh shifts (High Line) and/or a "Clicking" or cycling noise may be heard from the side cover area, that is usually accompanied by an ON/OFF bind-up sensation that coincides with the "Clicking" noise. These symptoms may be accompanied with Diagnostic Trouble Code (DTC) 652 (MLUS Shorted or Open Circuit), DTC 624 (EPC Circuit Failure), and/or one Shift Solenoid DTC 621, 622, or 624.

**CAUSE:** The cause may be, solenoid wire connectors installed on the wrong solenoids.

1. EPC GROUND (VIOLET)
2. EPC AND MLUS POWER (LT GREEN)
3. SS3 GROUND (YELLOW)
4. MLUS GROUND (BROWN)
5. SHIFT SOLENOID POWER (RED)
6. SS1 GROUND (ORANGE)
7. TFT (BLACK)
8. SS2 GROUND (PINK)
9. TFT RETURN (PINK)

### "LATE" AXODE WIRE COLORS

**NOTE:** The internal wire harness normally is secured by wire-ties which would prevent improper connection of solenoids, however, not all wire harnesses have the wire ties necessary to prevent this problem and the chart must be used.

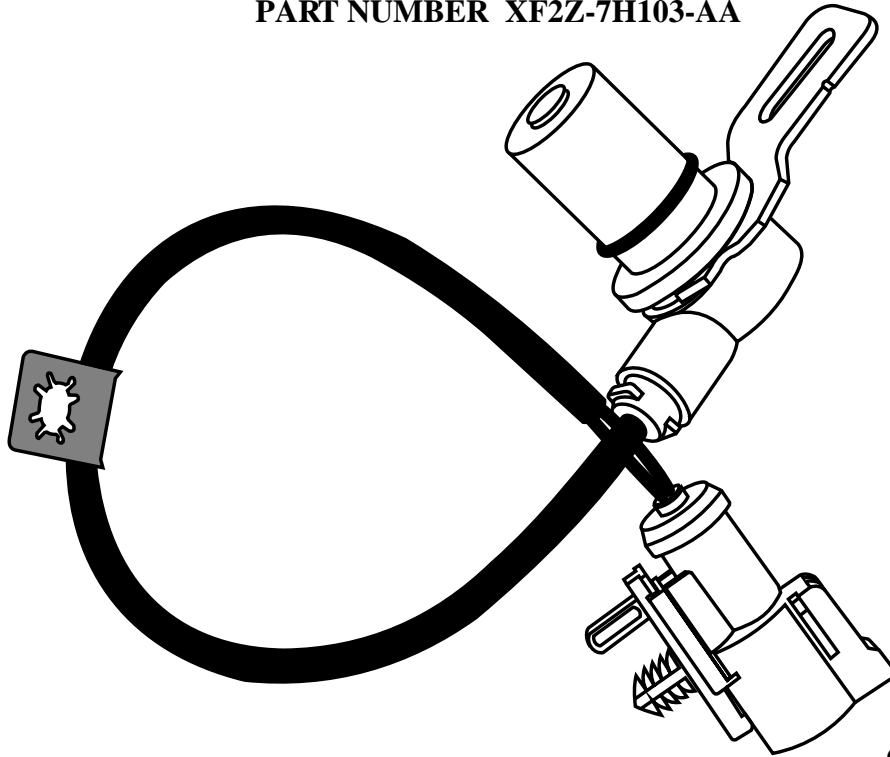
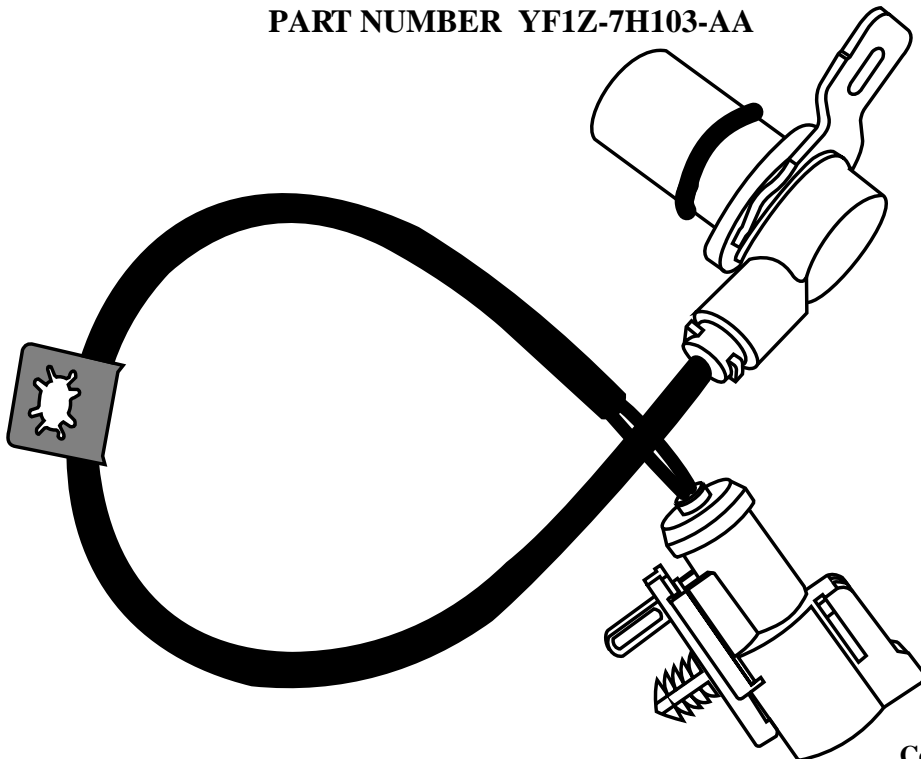
**CHANGE:** The gear driven vehicle speed sensor that has been in use in the AX4S and the AX4N since their inception will be replaced, as a running change during the 1999 model year beginning with the AX4S, and at the start of production for the 2000 model year for the AX4N, with a permanent magnet speed sensor. The PM Generator will be mounted in the barrel of the case and will be using the park gear teeth as an exciter wheel.

**REASON:** The possibility of the VSS drive or driven gear "apple coring" will be eliminated as well as the intermittent loss of vehicle speed signal due to the speed sensor sub harness damage that would occur as a result of exhaust system heat transferral.

**AX4S VEHICLE SPEED SENSOR**

**AX4N VEHICLE SPEED SENSOR**

AX4S Vehicle Speed Sensor.....	XF2Z-7H103-AA
AX4N Vehicle Speed Sensor.....	YF1Z-7H103-AA

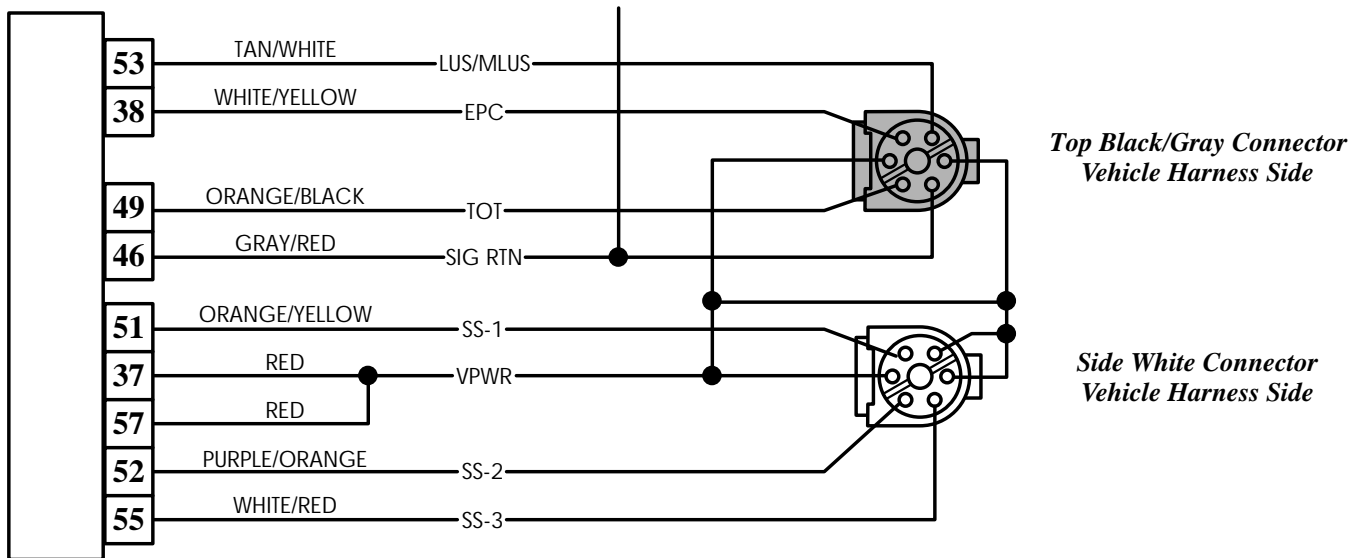
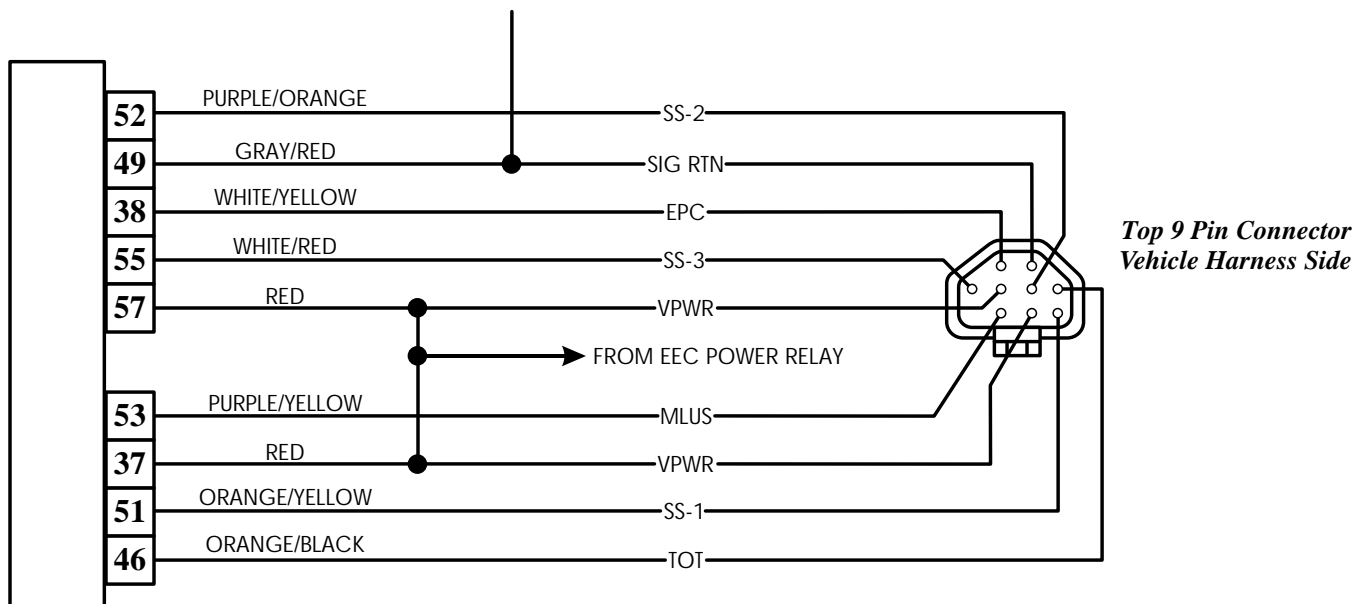
Figure 98

To begin the EPC circuit current draw test, the EPC ground wire that runs from the computer to the transaxle case connector must be located, and the external wire color will be White with a Yellow tracer on both versions, as shown in Figure 98. On 1991-1992 model vehicles the wire will be found in the top case connector and comes from pin number 38 on the computer. On 1993-UP vehicles there is only one case connector and the wire still comes from pin number 38 on the computer. Refer to Figure 98.

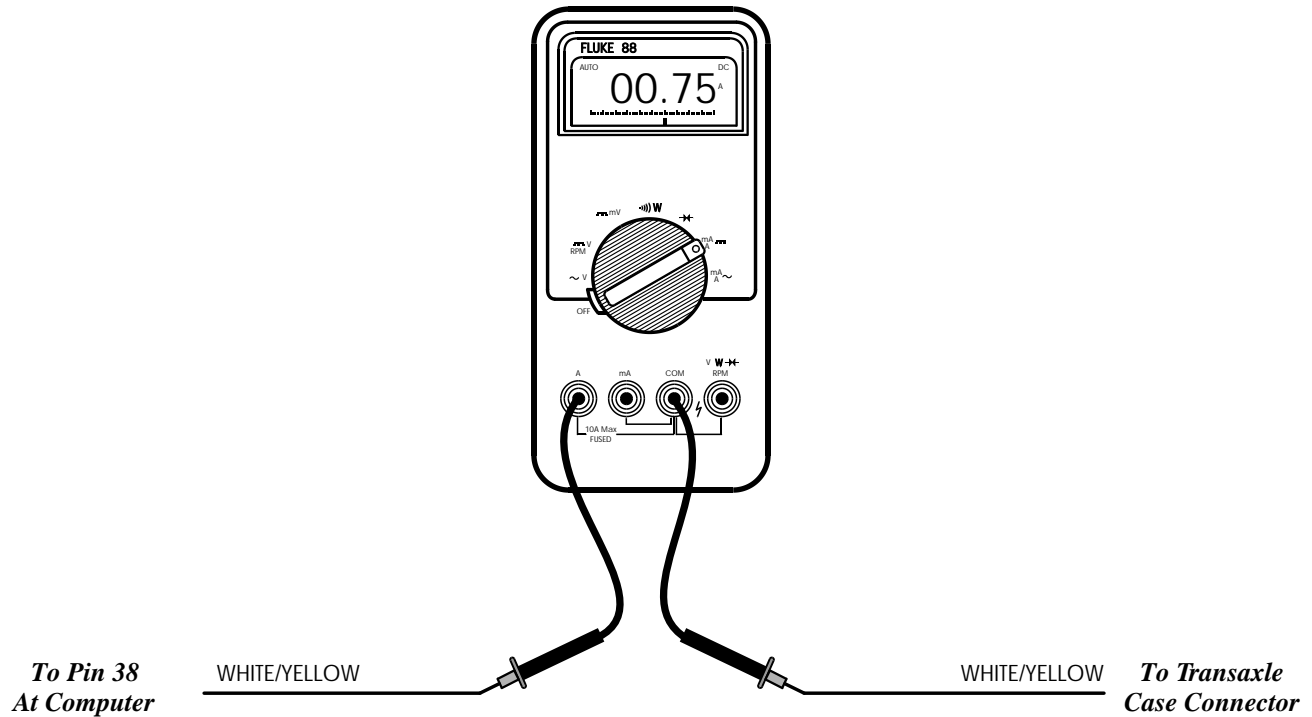
Figure 99

Connect the 0-400 lb. pressure gauge to the mainline pressure tap, as shown in Figure 100. Cut the White wire with the Yellow tracer and hook the DVOM, **in series**, so that current flows **through** the DVOM, as shown in Figure 99. Start the engine and let it warm up until the pressure stabilizes between 48-77 PSI. The amperage reading at idle should be approximately 1 Amp. As the throttle is opened, amperage should begin to drop, and pressure should begin to rise. Refer to the chart in Figure 99.

*Cut the White/Yellow wire from Pin No. 38 at the computer and connect the DVOM leads, as shown above, to perform this test. This is known as "connecting in series".*

<b>EPC AMPS</b>	<b>1.0</b>	<b>.90</b>	<b>.75</b>	<b>.70</b>	<b>.60</b>	<b>.50</b>	<b>.35</b>	
<b>EPC PSI</b>	<b>20</b>	<b>30</b>	<b>40</b>	<b>50</b>	<b>60</b>	<b>70</b>	<b>80</b>	
<b>*P psi</b>	<b>75</b>	<b>----</b>	<b>----</b>	<b>----</b>	<b>----</b>	<b>----</b>	<b>----</b>	
<b>R psi</b>	<b>90</b>	<b>145</b>	<b>175</b>	<b>200</b>	<b>225</b>	<b>275</b>	<b>310</b>	
<b>N psi</b>	<b>75</b>	<b>----</b>	<b>----</b>	<b>----</b>	<b>----</b>	<b>----</b>	<b>----</b>	
<b>OD psi</b>	<b>75</b>	<b>100</b>	<b>125</b>	<b>145</b>	<b>165</b>	<b>180</b>	<b>210</b>	
<b>D psi</b>	<b>75</b>	<b>100</b>	<b>125</b>	<b>145</b>	<b>165</b>	<b>180</b>	<b>210</b>	
<b>L psi</b>	<b>80</b>	<b>100</b>	<b>125</b>	<b>155</b>	<b>175</b>	<b>190</b>	<b>220</b>

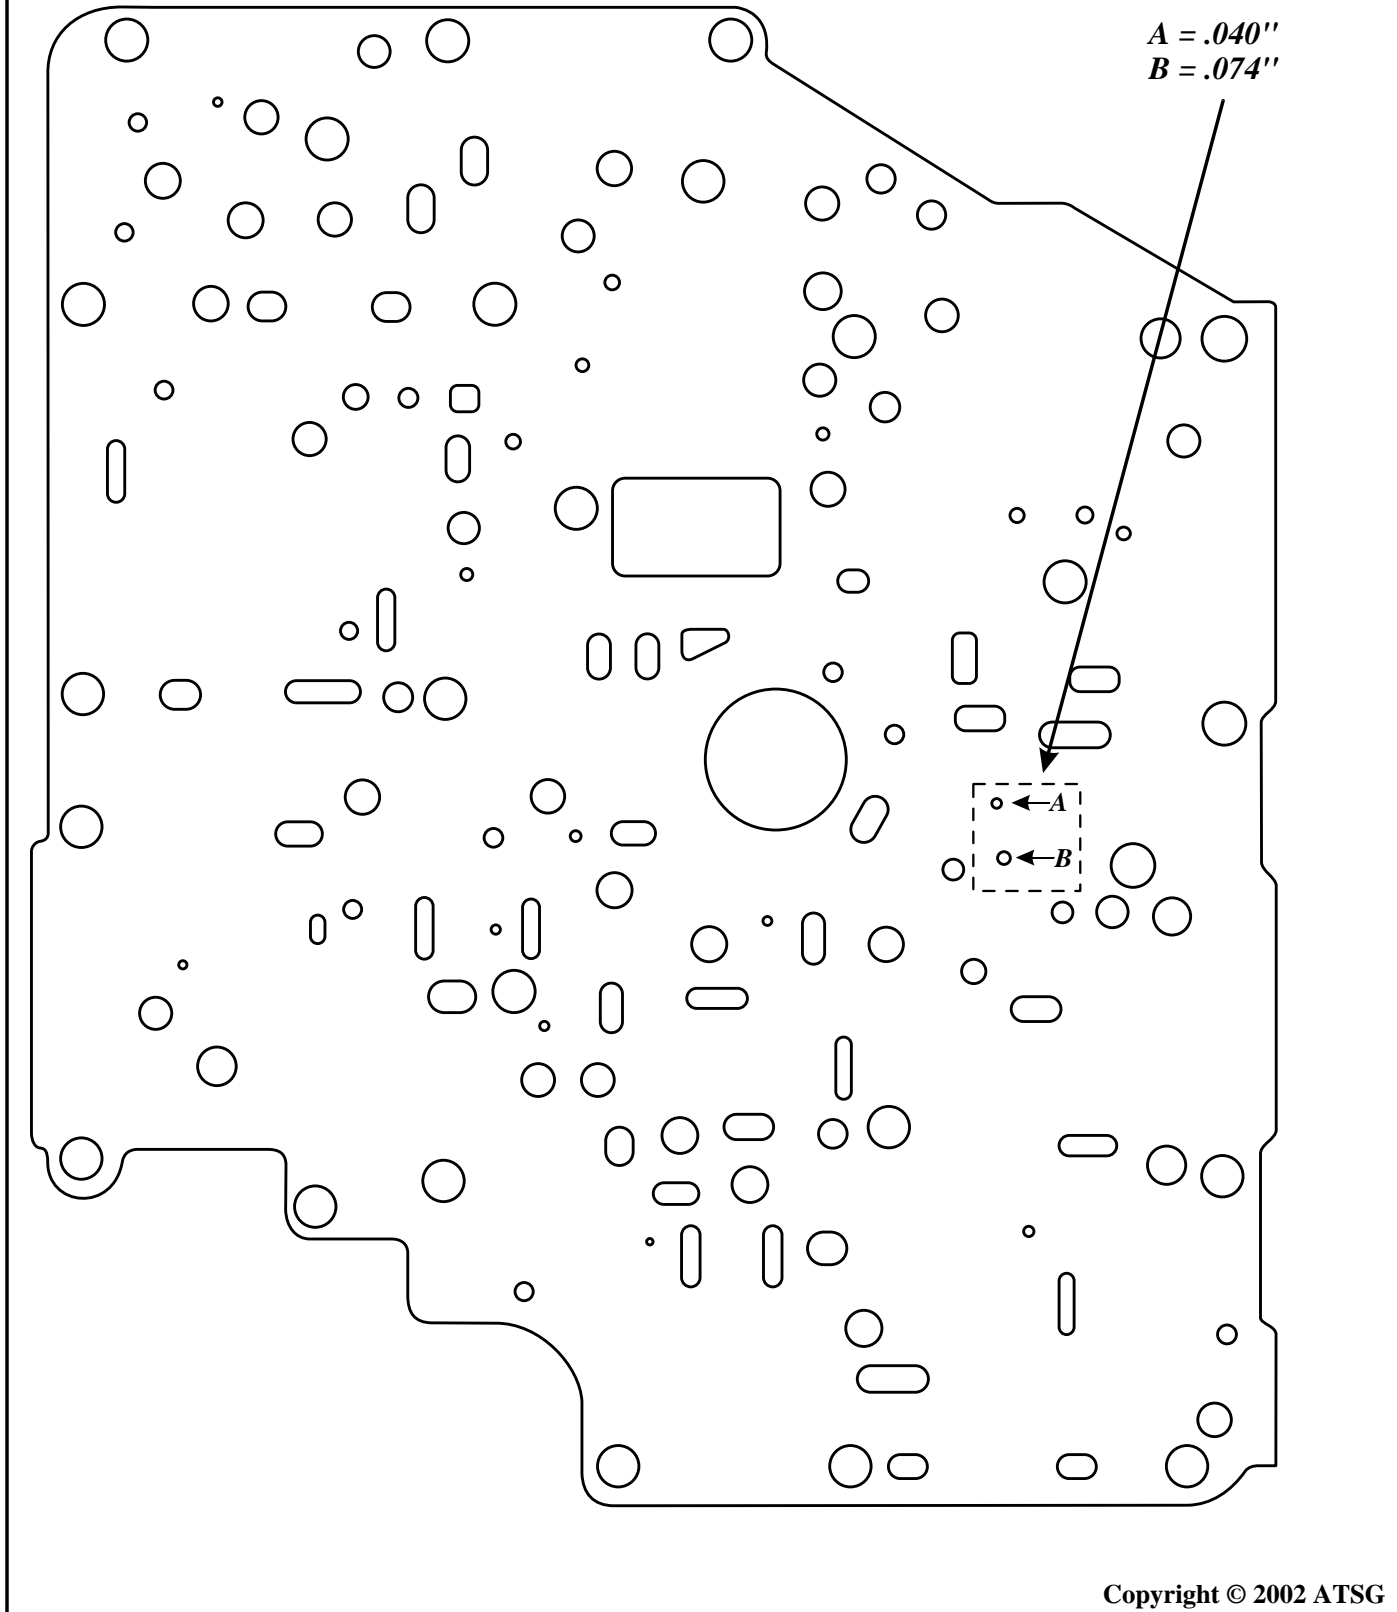
**CAUSE:** The cause may be, a valve body spacer plate designed for the Taurus, Sable, Continental passenger car family, has been installed on a Windstar Van, creating a harsh 1-2 upshift. If the Windstar Van valve body spacer plate, is installed on the Taurus, Sable, Continental family of vehicles, the result will be a soft or flared 1-2 upshift. ***Obviously these two spacer plates are different.*** Refer to Figures 101 and 102, using the two holes over the 1-2 capacity modulator valve area, for identification.

"WINDSTAR" SPACER PLATE IDENTIFICATION

**CORRECTION:** Install the proper valve body spacer plate for the Ford family that you happen to be servicing at this time. Refer to the illustration in Figure 101 to identify the valve body spacer plate for the Windstar Van. Refer to the illustration in Figure 102 to identify the valve body spacer plate for the Taurus, Sable and Continental family.
