# AXOD/AXODE (AX4S) UPDATE HANDBOOK

*Updated  
October, 2002*

Since the introduction of the Ford AXOD transaxle in model year 1986, there have been many major engineering design changes that have affected many of the parts used in the AXOD transaxle. This version of the AXOD "Update Handbook" begins with the 1986 model year and will explain each change, the parts affected by the change, and any parts interchange problems created by the change. This booklet is an updated version of the original.

This updated version of the AXOD "Update Handbook" will also cover the changes that occurred in the 1991 model year, when electronic controls were adapted to the AXOD transaxle, making it an AXODE, and now called an AX4S transaxle. We have included the changes on the AX4S transaxle up through and including model year 2002.

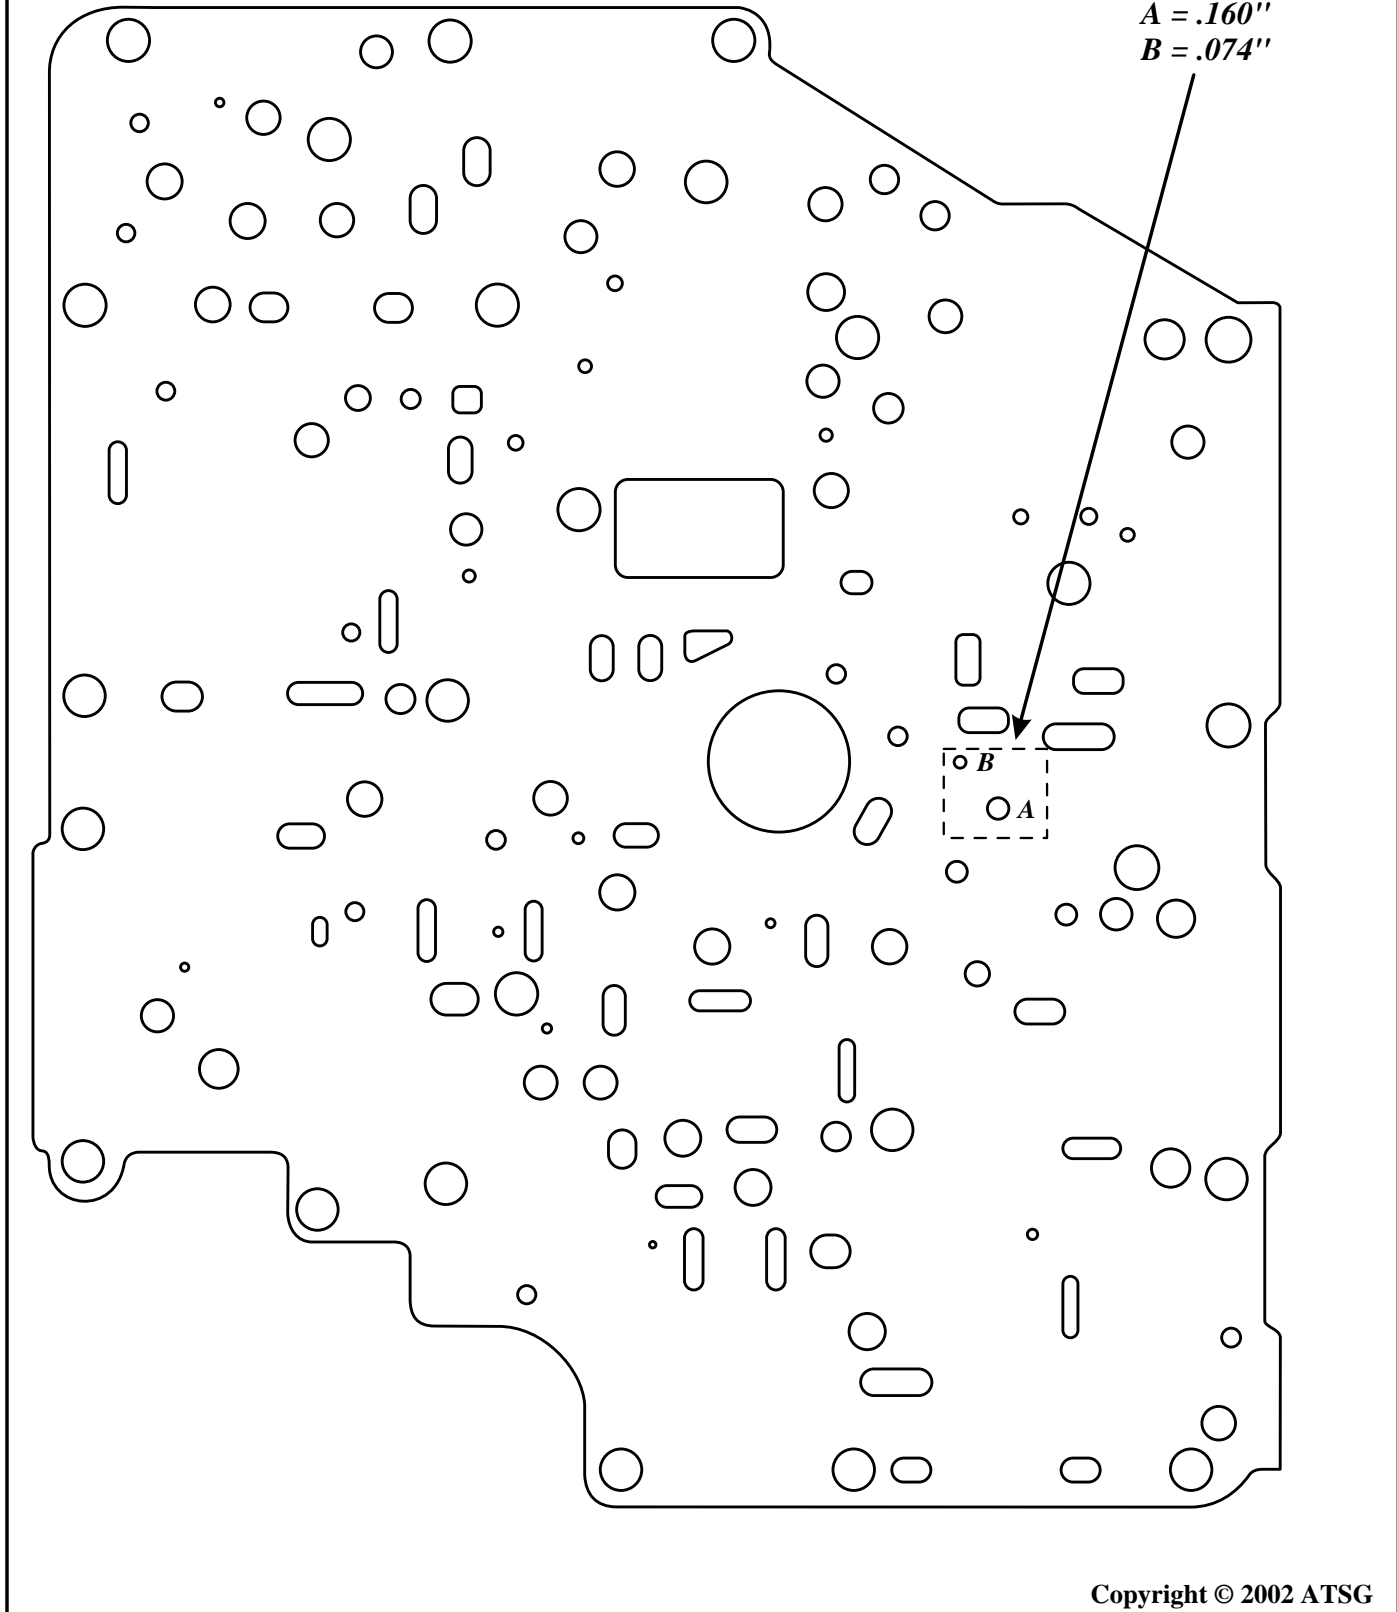
**CAUSE:** The cause may be, a valve body spacer plate designed for the Taurus, Sable, Continental passenger car family, has been installed on a Windstar Van, creating a harsh 1-2 upshift. If the Windstar Van valve body spacer plate, is installed on the Taurus, Sable, Continental family of vehicles, the result will be a soft or flared 1-2 upshift. ***Obviously these two spacer plates are different.*** Refer to Figures 101 and 102, using the two holes over the 1-2 capacity modulator valve area, for identification.

"TAURUS FAMILY" SPACER PLATE IDENTIFICATION

**CORRECTION:** Install the proper valve body spacer plate for the Ford family that you happen to be servicing at this time. Refer to the illustration in Figure 101 to identify the valve body spacer plate for the Windstar Van. Refer to the illustration in Figure 102 to identify the valve body spacer plate for the Taurus, Sable and Continental family.

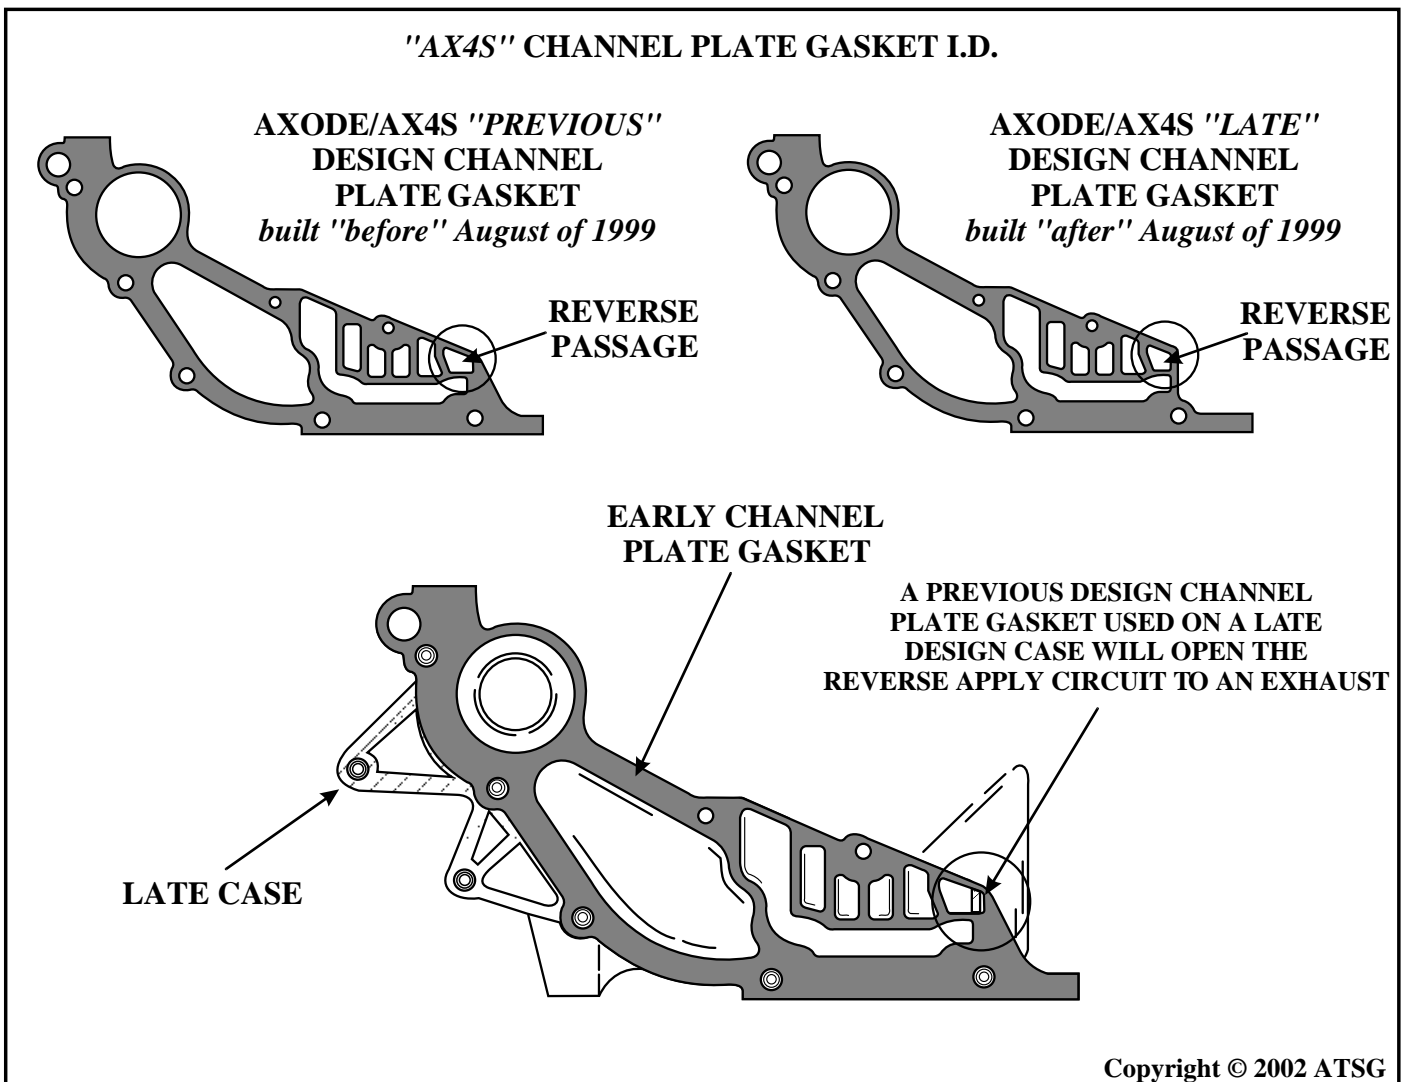
**CAUSE:** The cause may be, that the *Previous Design* Channel Plate Gasket, was used on a *Late Design* case as shown in Figure 103. When this happens, Reverse apply pressure will be exhausted back into the case because of the gasket hanging over the case casting.

**CORRECTION:** AX4S-Refer to Figure 103 to identify the correct Channel Plate Gasket for the application of vehicle you are working on.  
AX4N-Refer to Figure 104 to identify the correct Channel Plate Gasket for the application of vehicle you are working on.

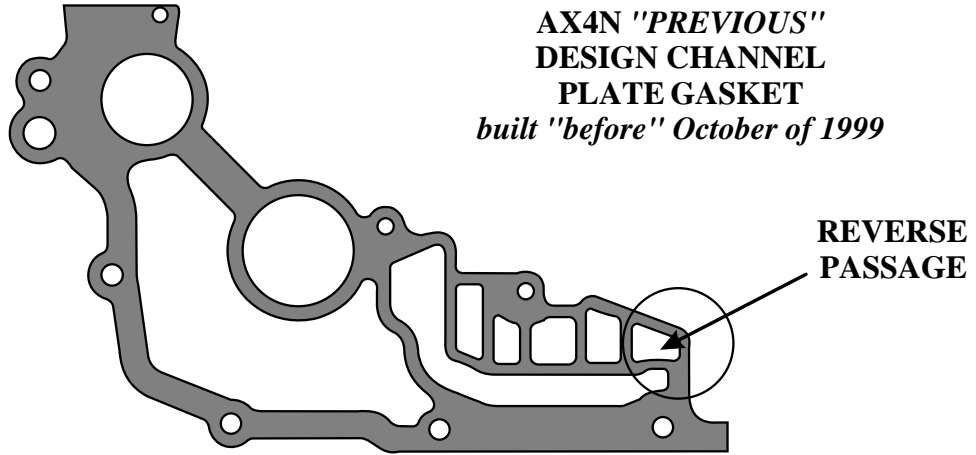
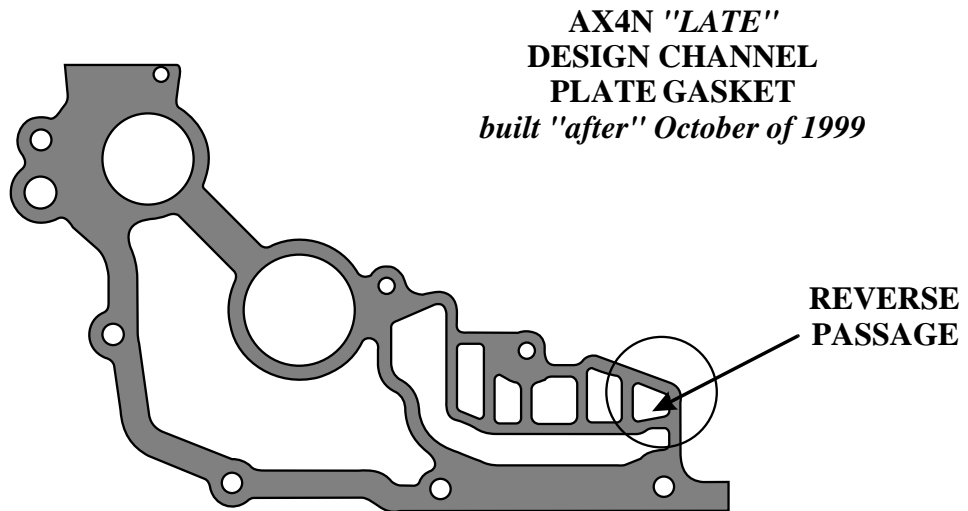
Figure 104

**"AX4N" CHANNEL PLATE GASKET I.D.**
